## Hornsby Shire Council

Hornsby Quarry Rehabilitation works including bulk earthworks (and associated civil works including construction of access tracks, drainage and retaining walls), site remediation, tree removal, revegetation work and site rehabilitation

Response to Submissions and Revised Project Scope

**VOLUME 2 – APPENDICES A to H**

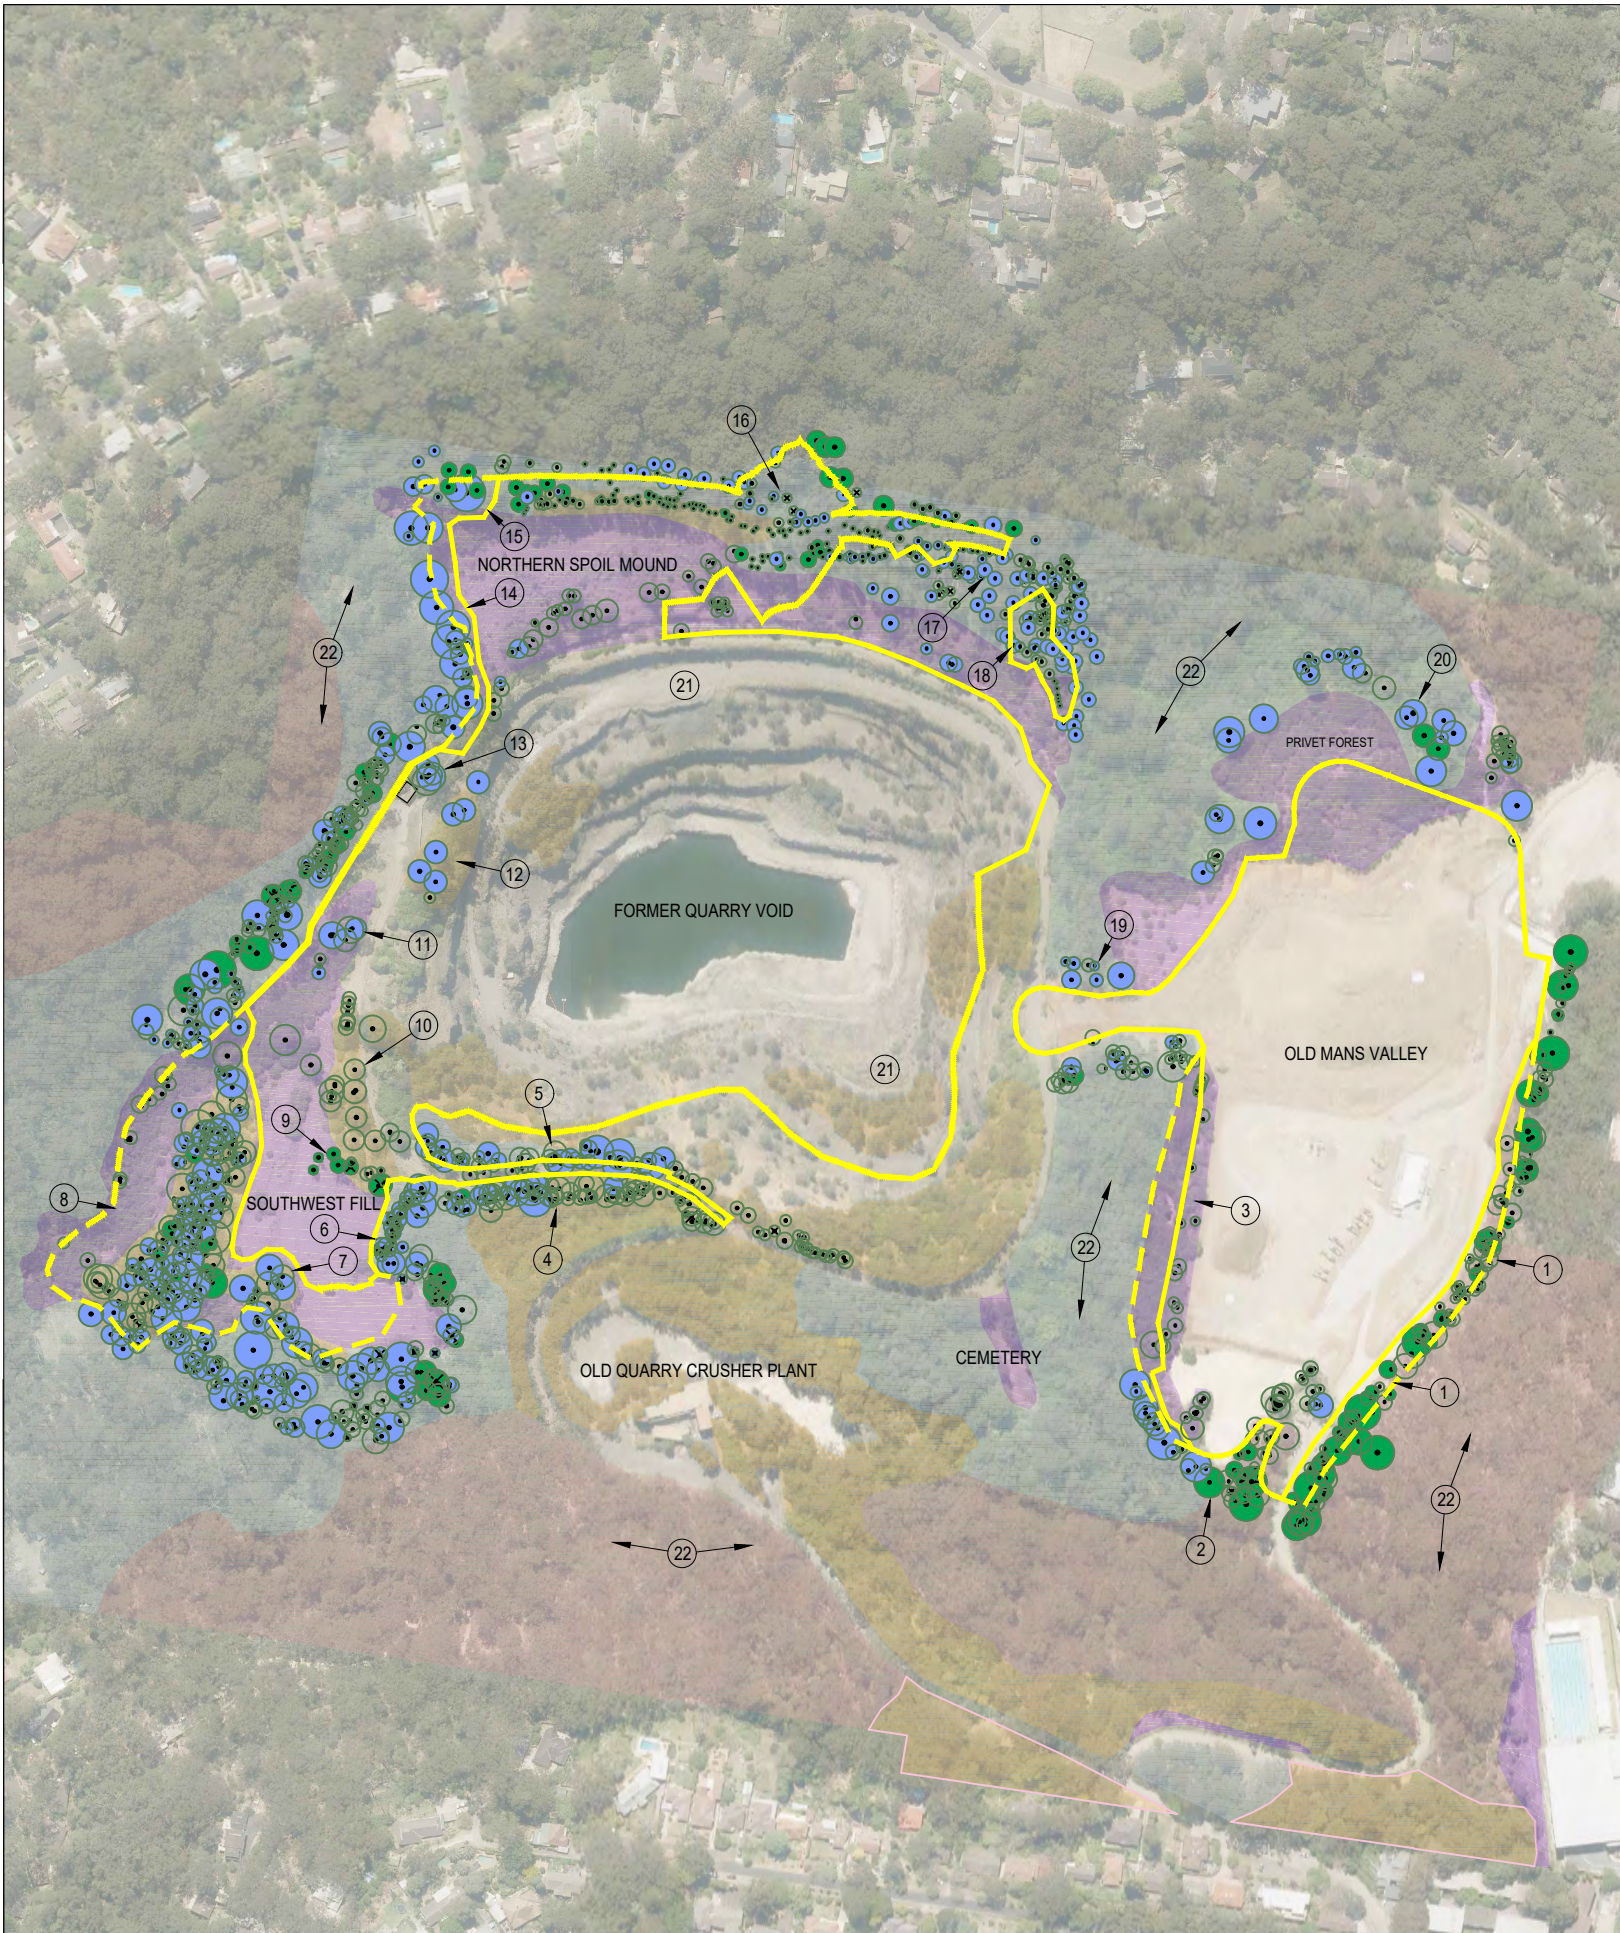
**NOTES - VEGETATION AND EXTENT OF WORKS**

- ① **Old Mans Valley (eastern edge area)**  
Significant trees and vegetation in this area are being protected. The Extent of Works line has been adjusted to protect Blackbutt Gully Forest. It is noted that the root zone of most trees here sit on a rock shelf high above the area of works.

- ② **Old Mans Valley (south area)**  
Design adjustments have been made to protect a Blue Gum tree in this vicinity.
- ③ **Old Mans Valley (west area)**  
The limit of works line has been adjusted to protect vegetation this area. Substantial rehabilitation and restoration of natural vegetation is planned for this area.

- ④ **Quarry South Track (upper side)**  
Very steep slopes with unconsolidated soils exist in this area. Significant native trees in this area will be retained and protected, as they are outside the Extent of Works. Some trees in this area have fallen due to extreme slope and unconsolidated soils. Trees that pose an unreasonable risk will be removed.

- ⑤ **Quarry South Track (lower side and Quarry Void slope)**  
Essential engineering works will be carried out to stabilise this track. Trackside vegetation protection will be prioritised in design and works. Extremely steep unstable slopes of the southern quarry walls will require detailed assessment. Depending on findings, works along the top of the cliff may require the removal of unstable trees that are vulnerable to failure and may contribute to further slope instability.

- ⑯ **Northern Spoil Mound (central area)**  
Due to an identified high risk of potential slope failure, this area will be subject to essential regrading, drainage rectification and remediation. As a result, tree vegetation in this area will need to be removed. With the works providing improved conditions for revegetation, substantial planting and restoration of natural forest vegetation is planned for this area. Adjacent areas outside the Extent of Works line will be protected.

- ⑱ **Northern Spoil Mound (north works area)**  
Due to an identified high risk of potential slope failure, this area will be subject to essential regrading and remediation. As a result, tree vegetation within the Extent of Works line will need to be removed. With the works providing improved conditions for revegetation, substantial planting and restoration of natural forest vegetation is planned for this area. Adjacent areas out of the limit of works line will be protected.

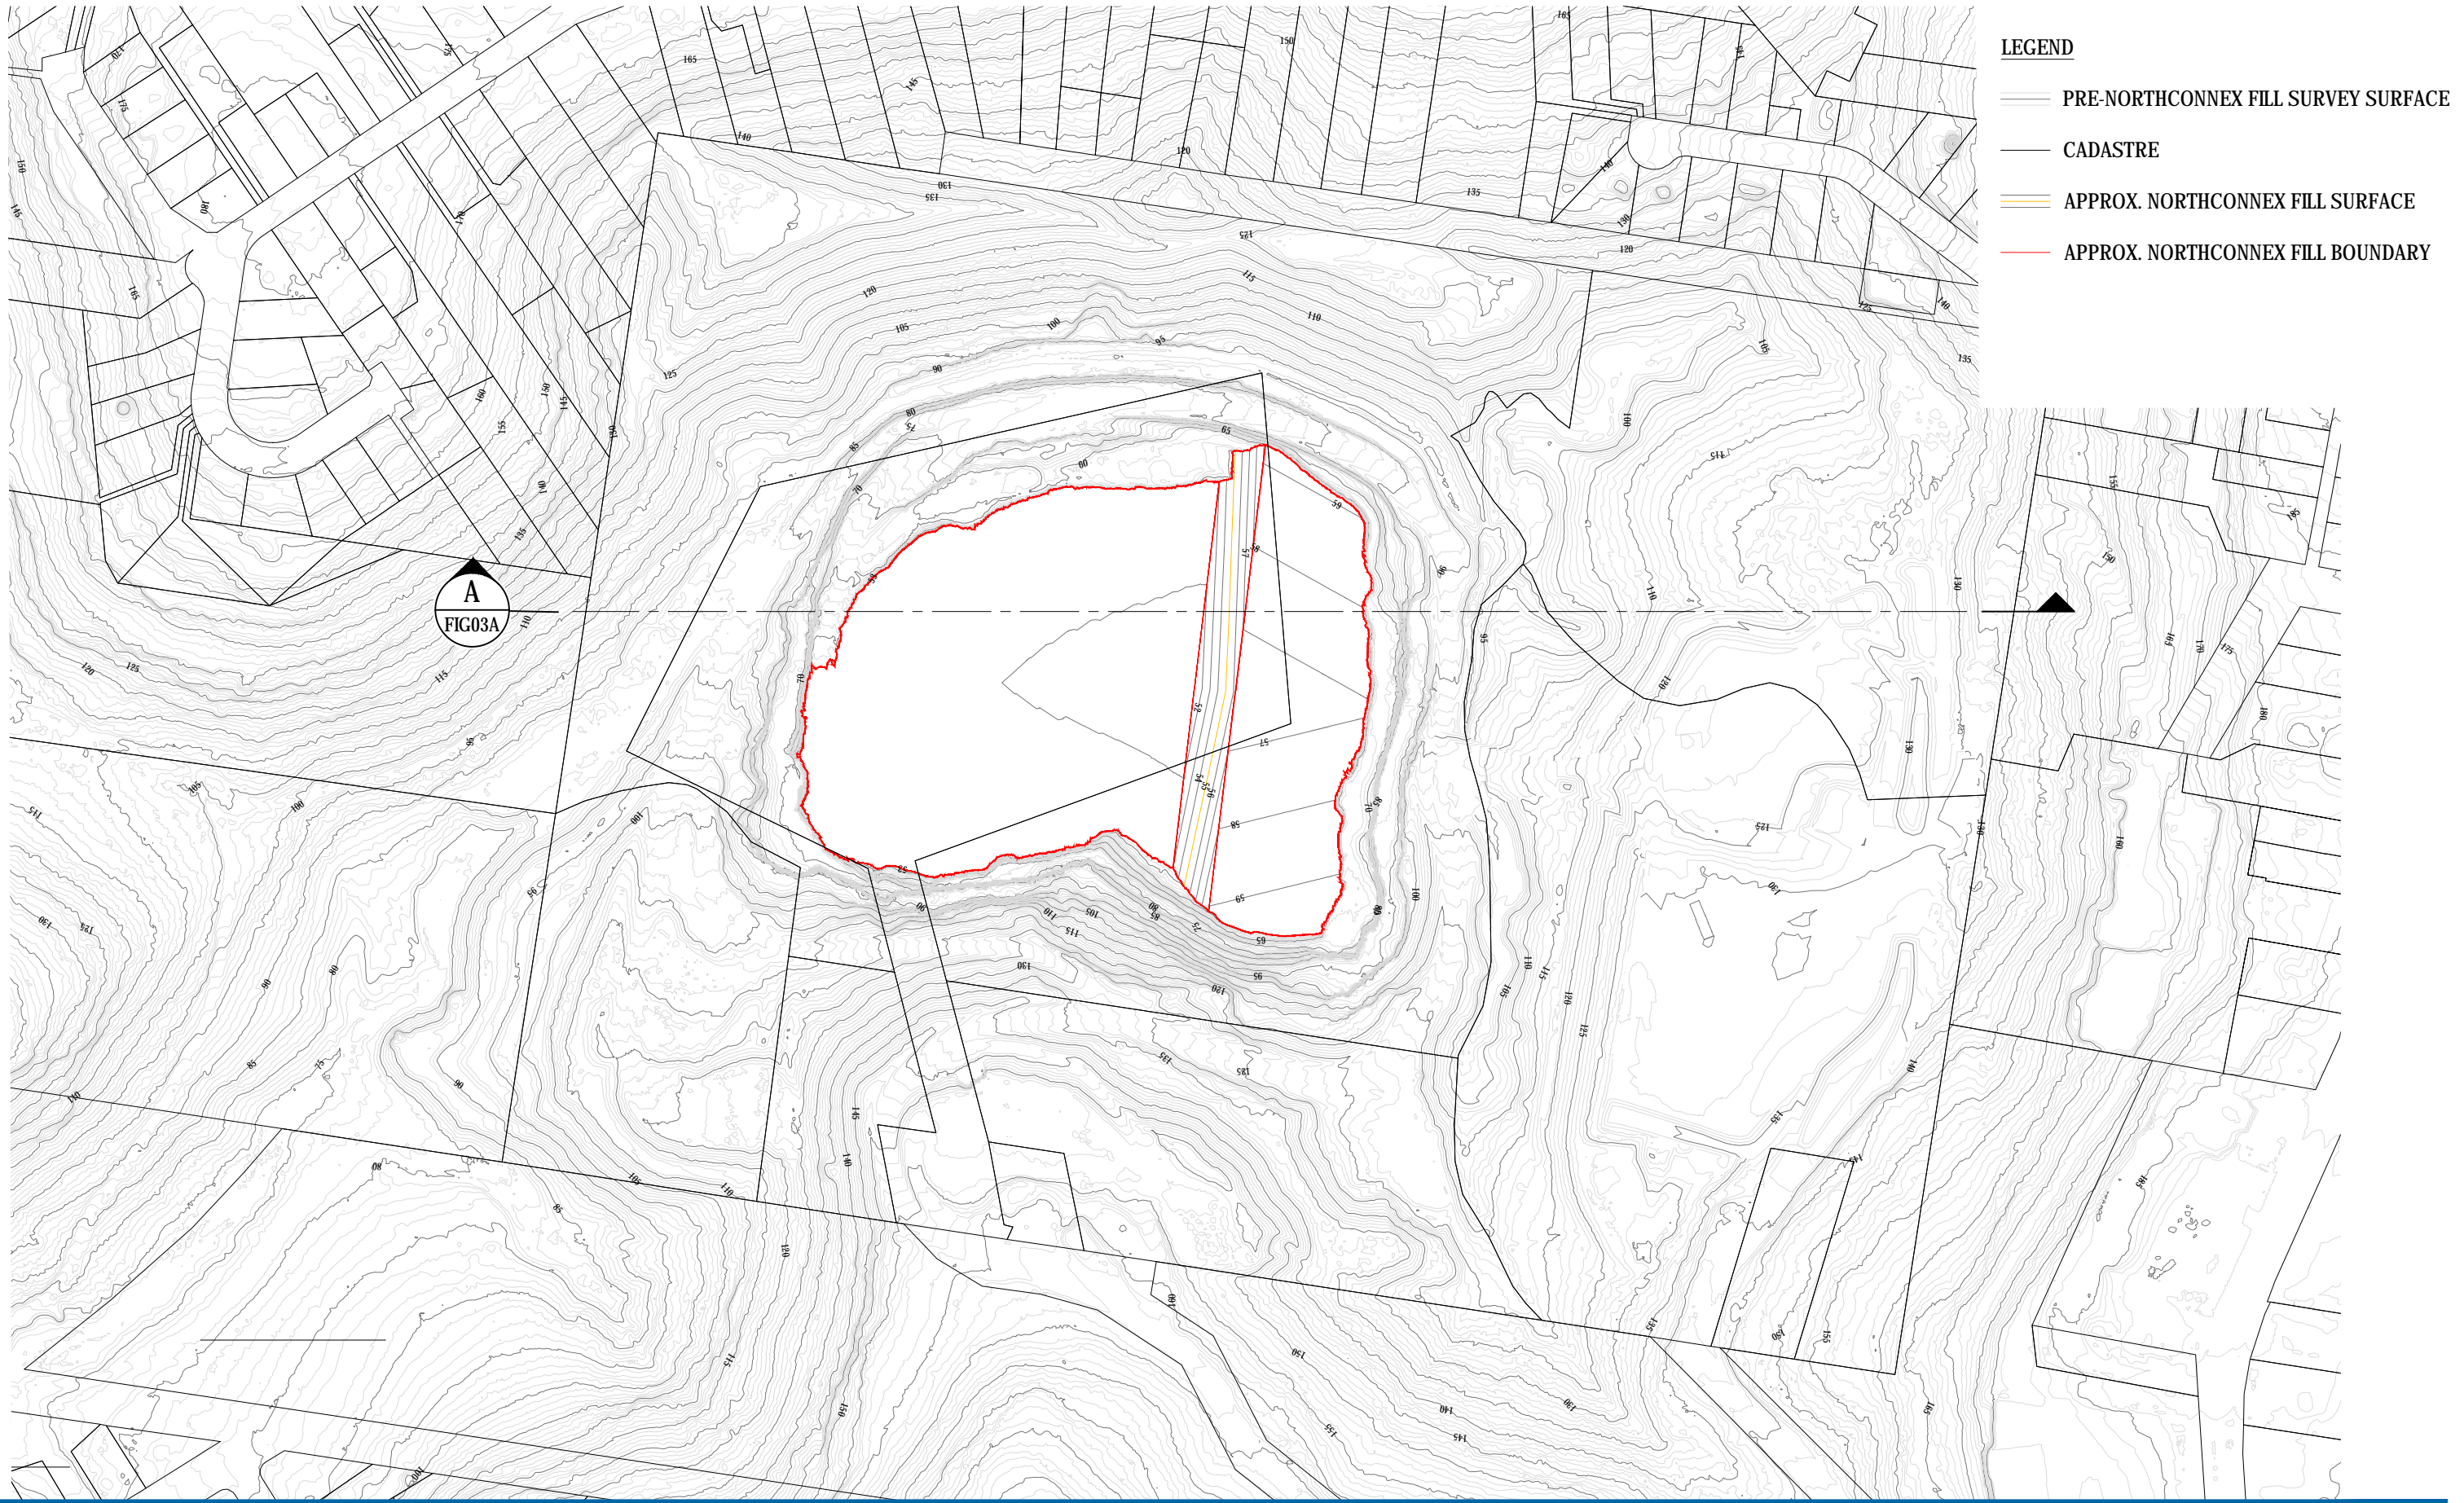
Project Number <b>100125</b>		
Sheet	of	Issue
<b>1</b>	<b>1</b>	<b>A</b>
HSC Drawing Number -

- ⑧ **South West Area (west side)**  
The Extent of Works has been amended here to ensure protection of quality vegetation, including Blue Gum and Blackbutt trees in this area.

**REVISED EXTENT OF WORKS AND VEGETATION MAPPING**

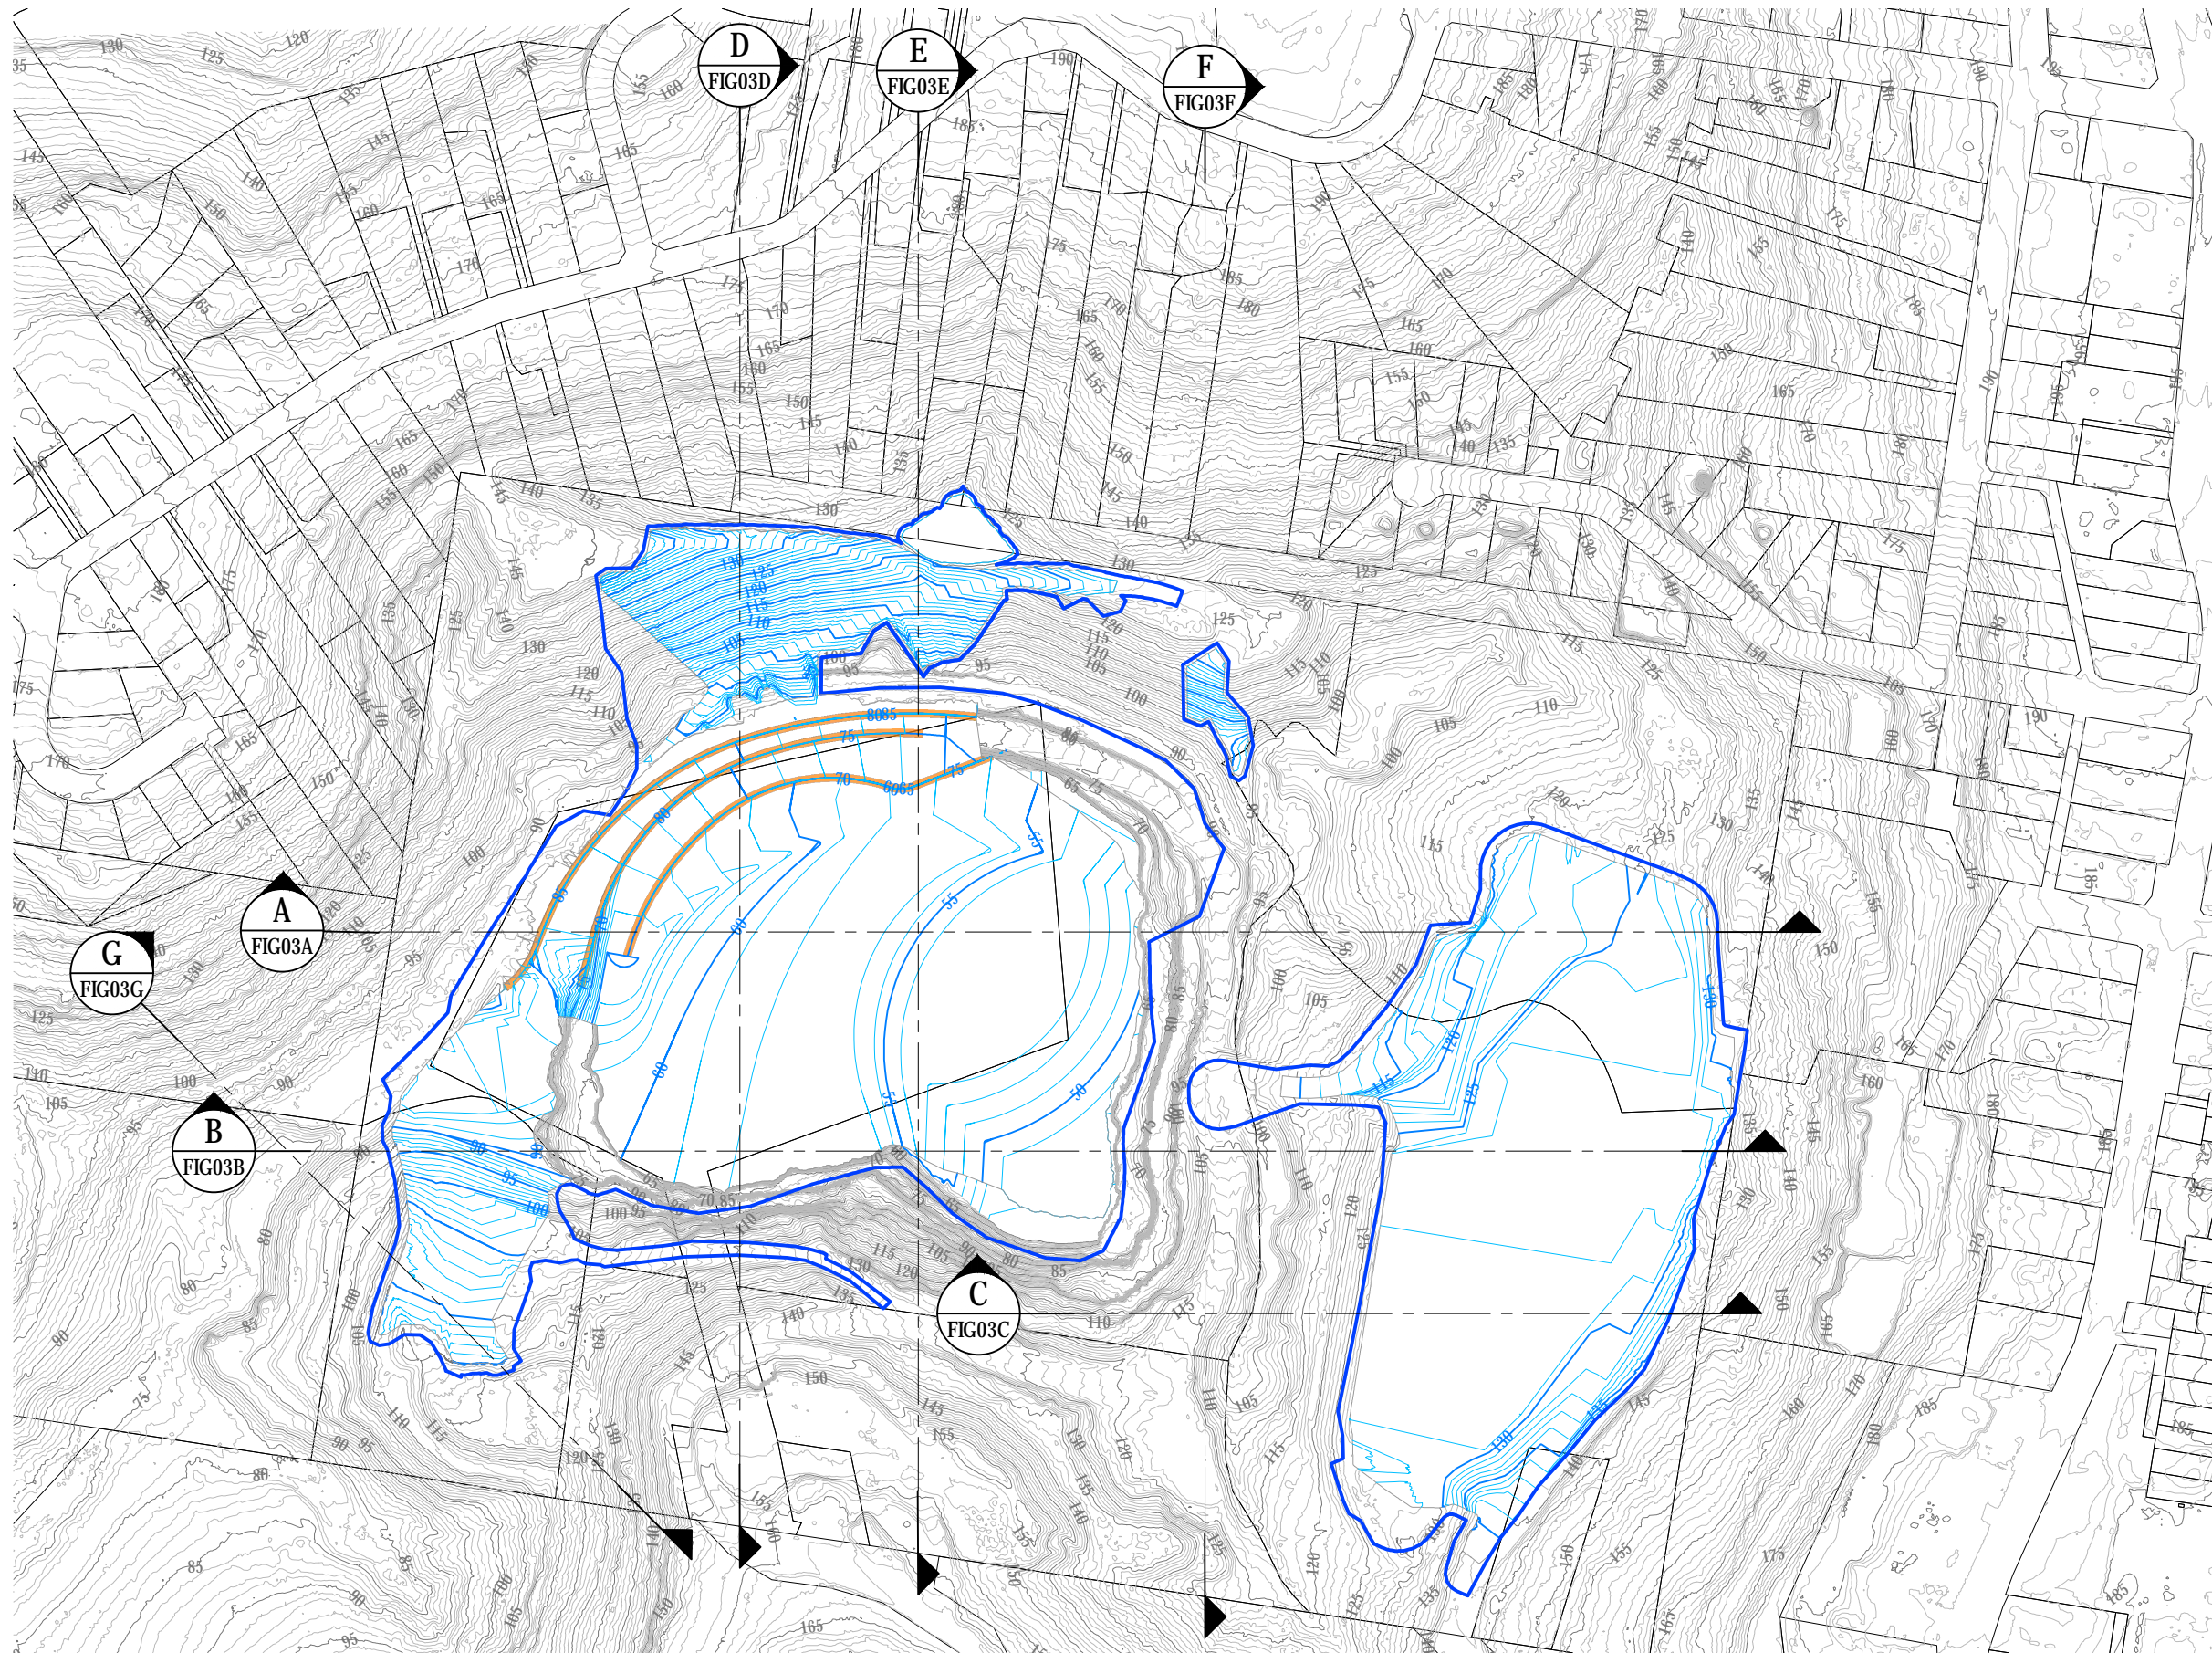
Job Number | 21-26457  
Revision | E  
Date | NOV 2019  
**Figure 01**

HORNSBY SHIRE COUNCIL  
HORNSBY QUARRY REHABILITATION  
**EXISTING SITE PLAN**

Ref	Comment	Response
<b>2.1</b>	<b>Description of Proposed Development</b>	
	It is recommended that the Applicant more clearly define the description of the development	The title is considered to reflect the works required.
<b>2.2</b>	<b>DA Plans</b>	
	Figure 01 - Existing Site Plan - cadastre (lot boundaries) are required to be shown	Refer revised Figure 01 showing cadastre
	Figure 02 - Proposed Landform - show cadastre - additional sections are required. Attachment 1 shows locations of required additional sections. Sections are to extend across the whole of the site and include properties beyond the site as a point of reference - this plan appears to be inconsistent with Drawing - Project Number 100125, Sheet 1 of 8 and Figure 6.2 in the EIS, particularly in relation to the works associated with the south-western stockpile. Figure 6.2 shows cut in this part of the site. (NOTE: Figure 6.2 appears to be based on the proposed landform. This should be based on the existing landform).	Refer revised Figure 02 showing cadastre and additional sections. See revised drawings - Project Number 100125 (11 Sheets)

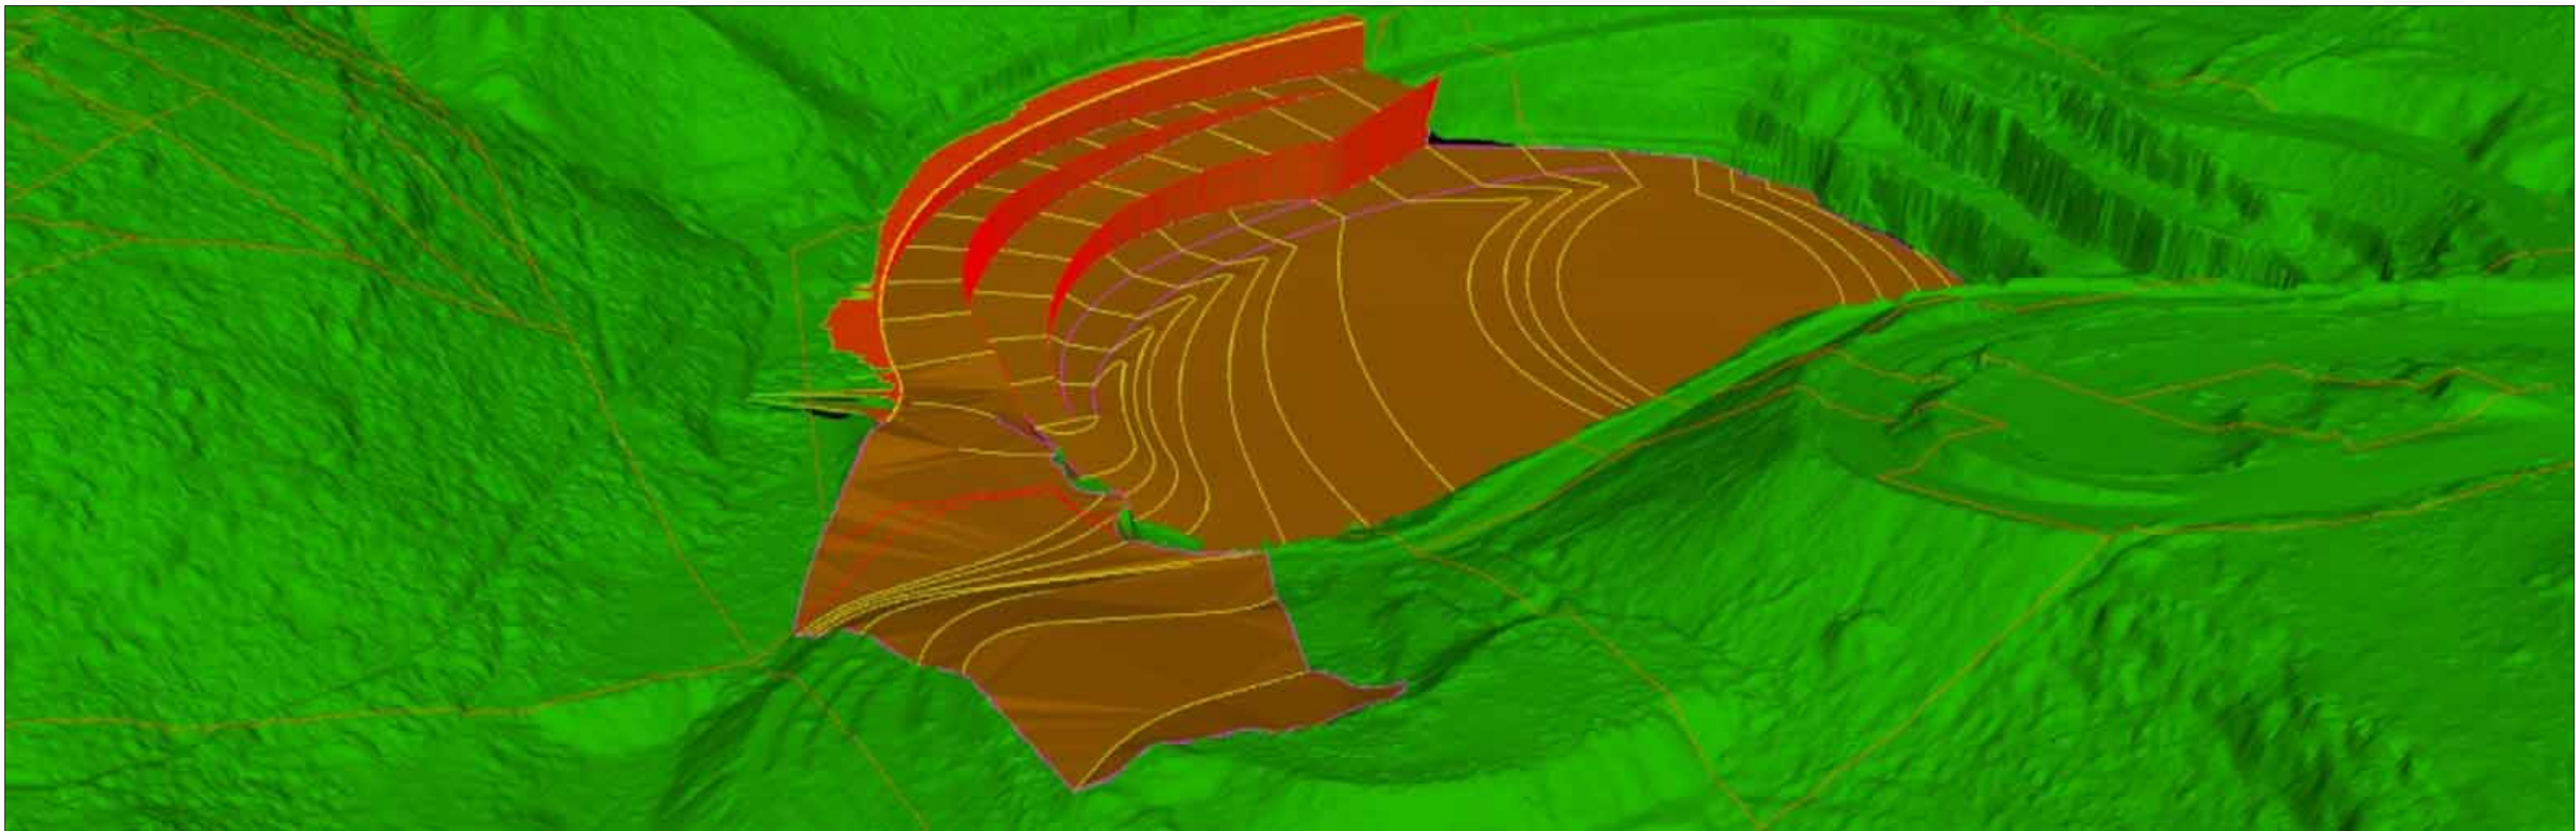
CONCEPTUAL DESIGN - LOOKING NORTHEAST

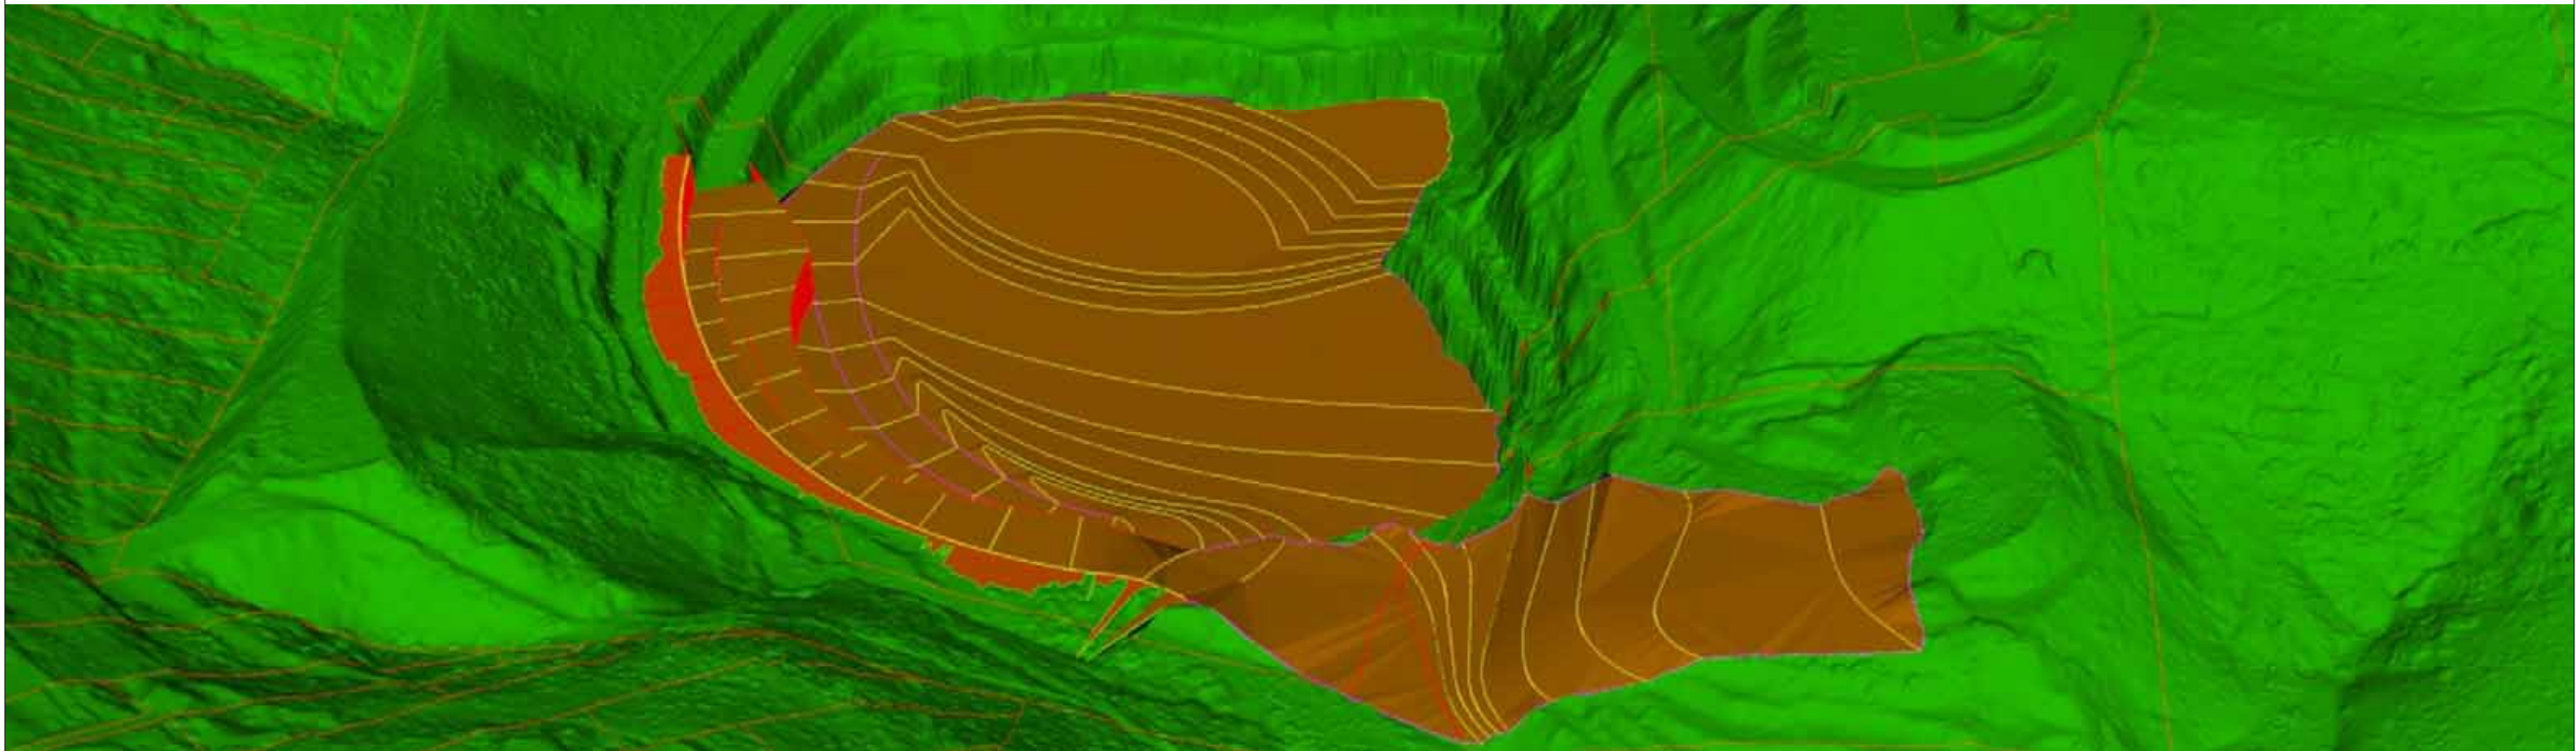
CONCEPTUAL DESIGN - LOOKING EAST

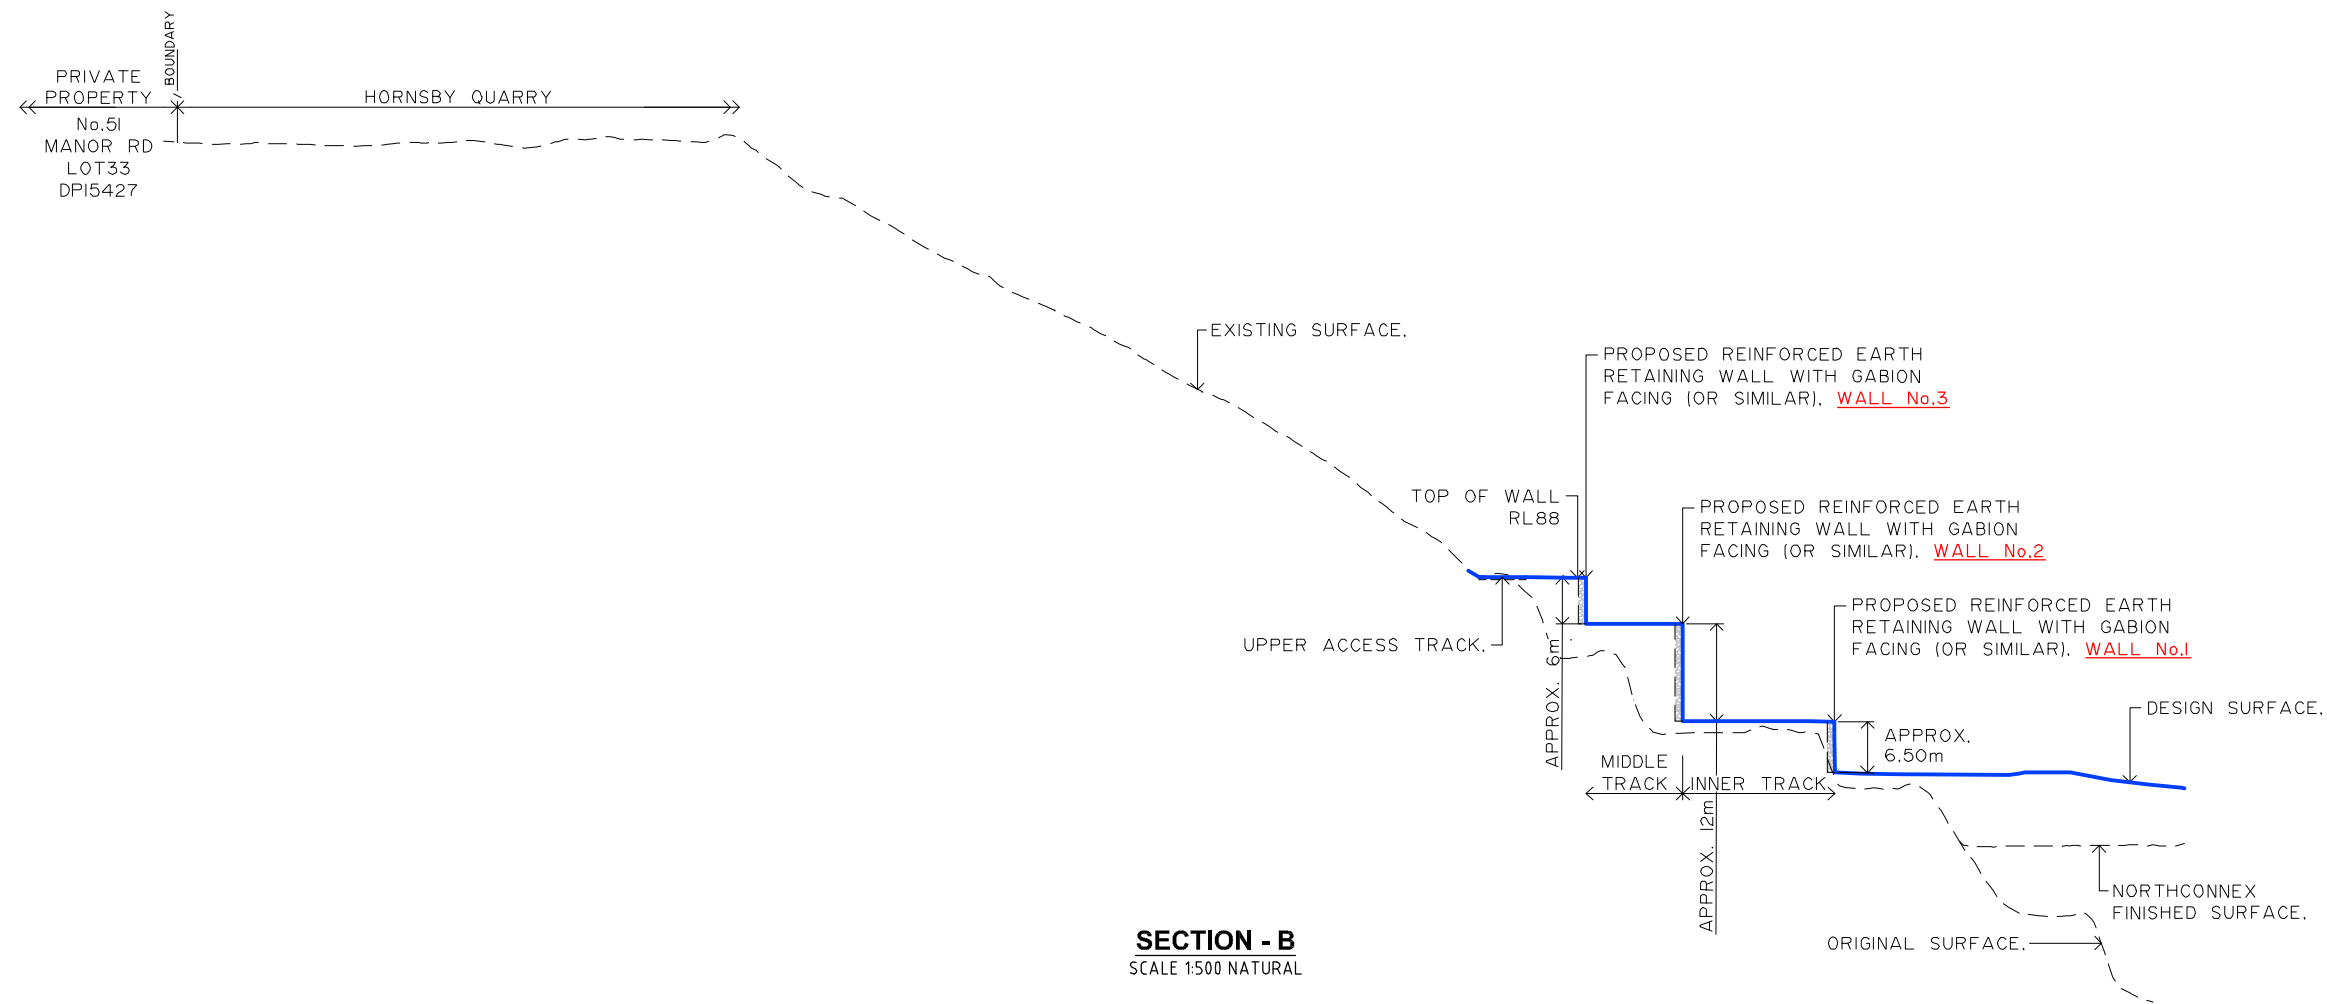
**SECTION - B**  
SCALE 1:500 NATURAL

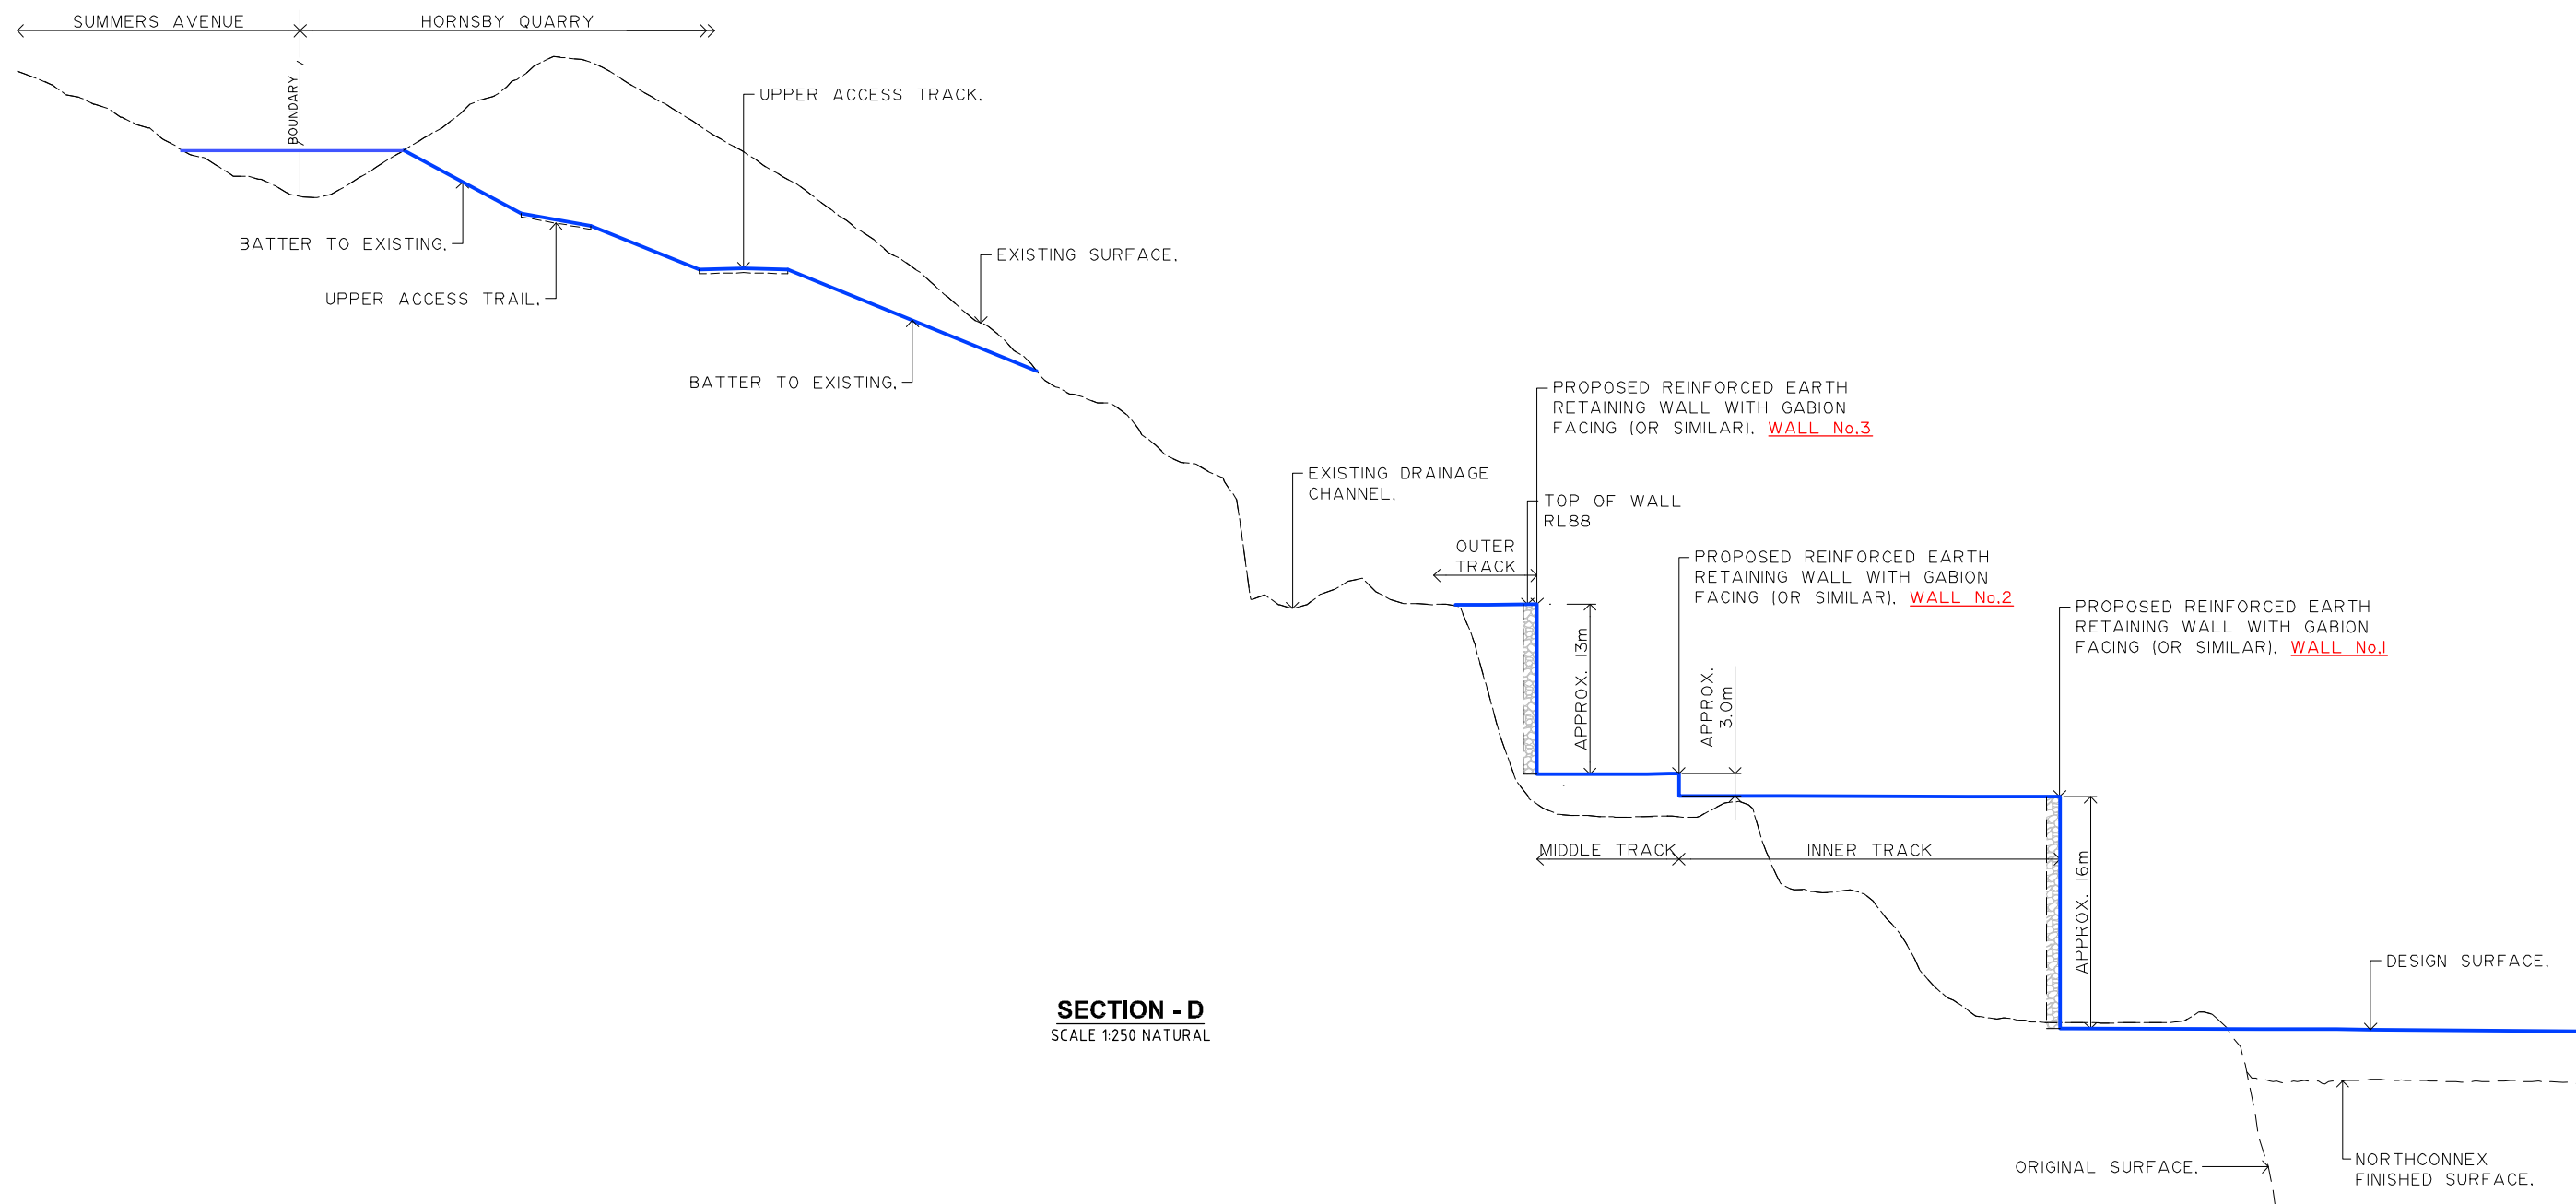
**SECTION - D**  
SCALE 1:250 NATURAL
