## Hornsby Shire Council

Hornsby Quarry Rehabilitation works including bulk earthworks (and associated civil works including construction of access tracks, drainage and retaining walls), site remediation, tree removal, revegetation work and site rehabilitation

Response to Submissions and Revised Project Scope

**VOLUME 2 – APPENDICES A to H**

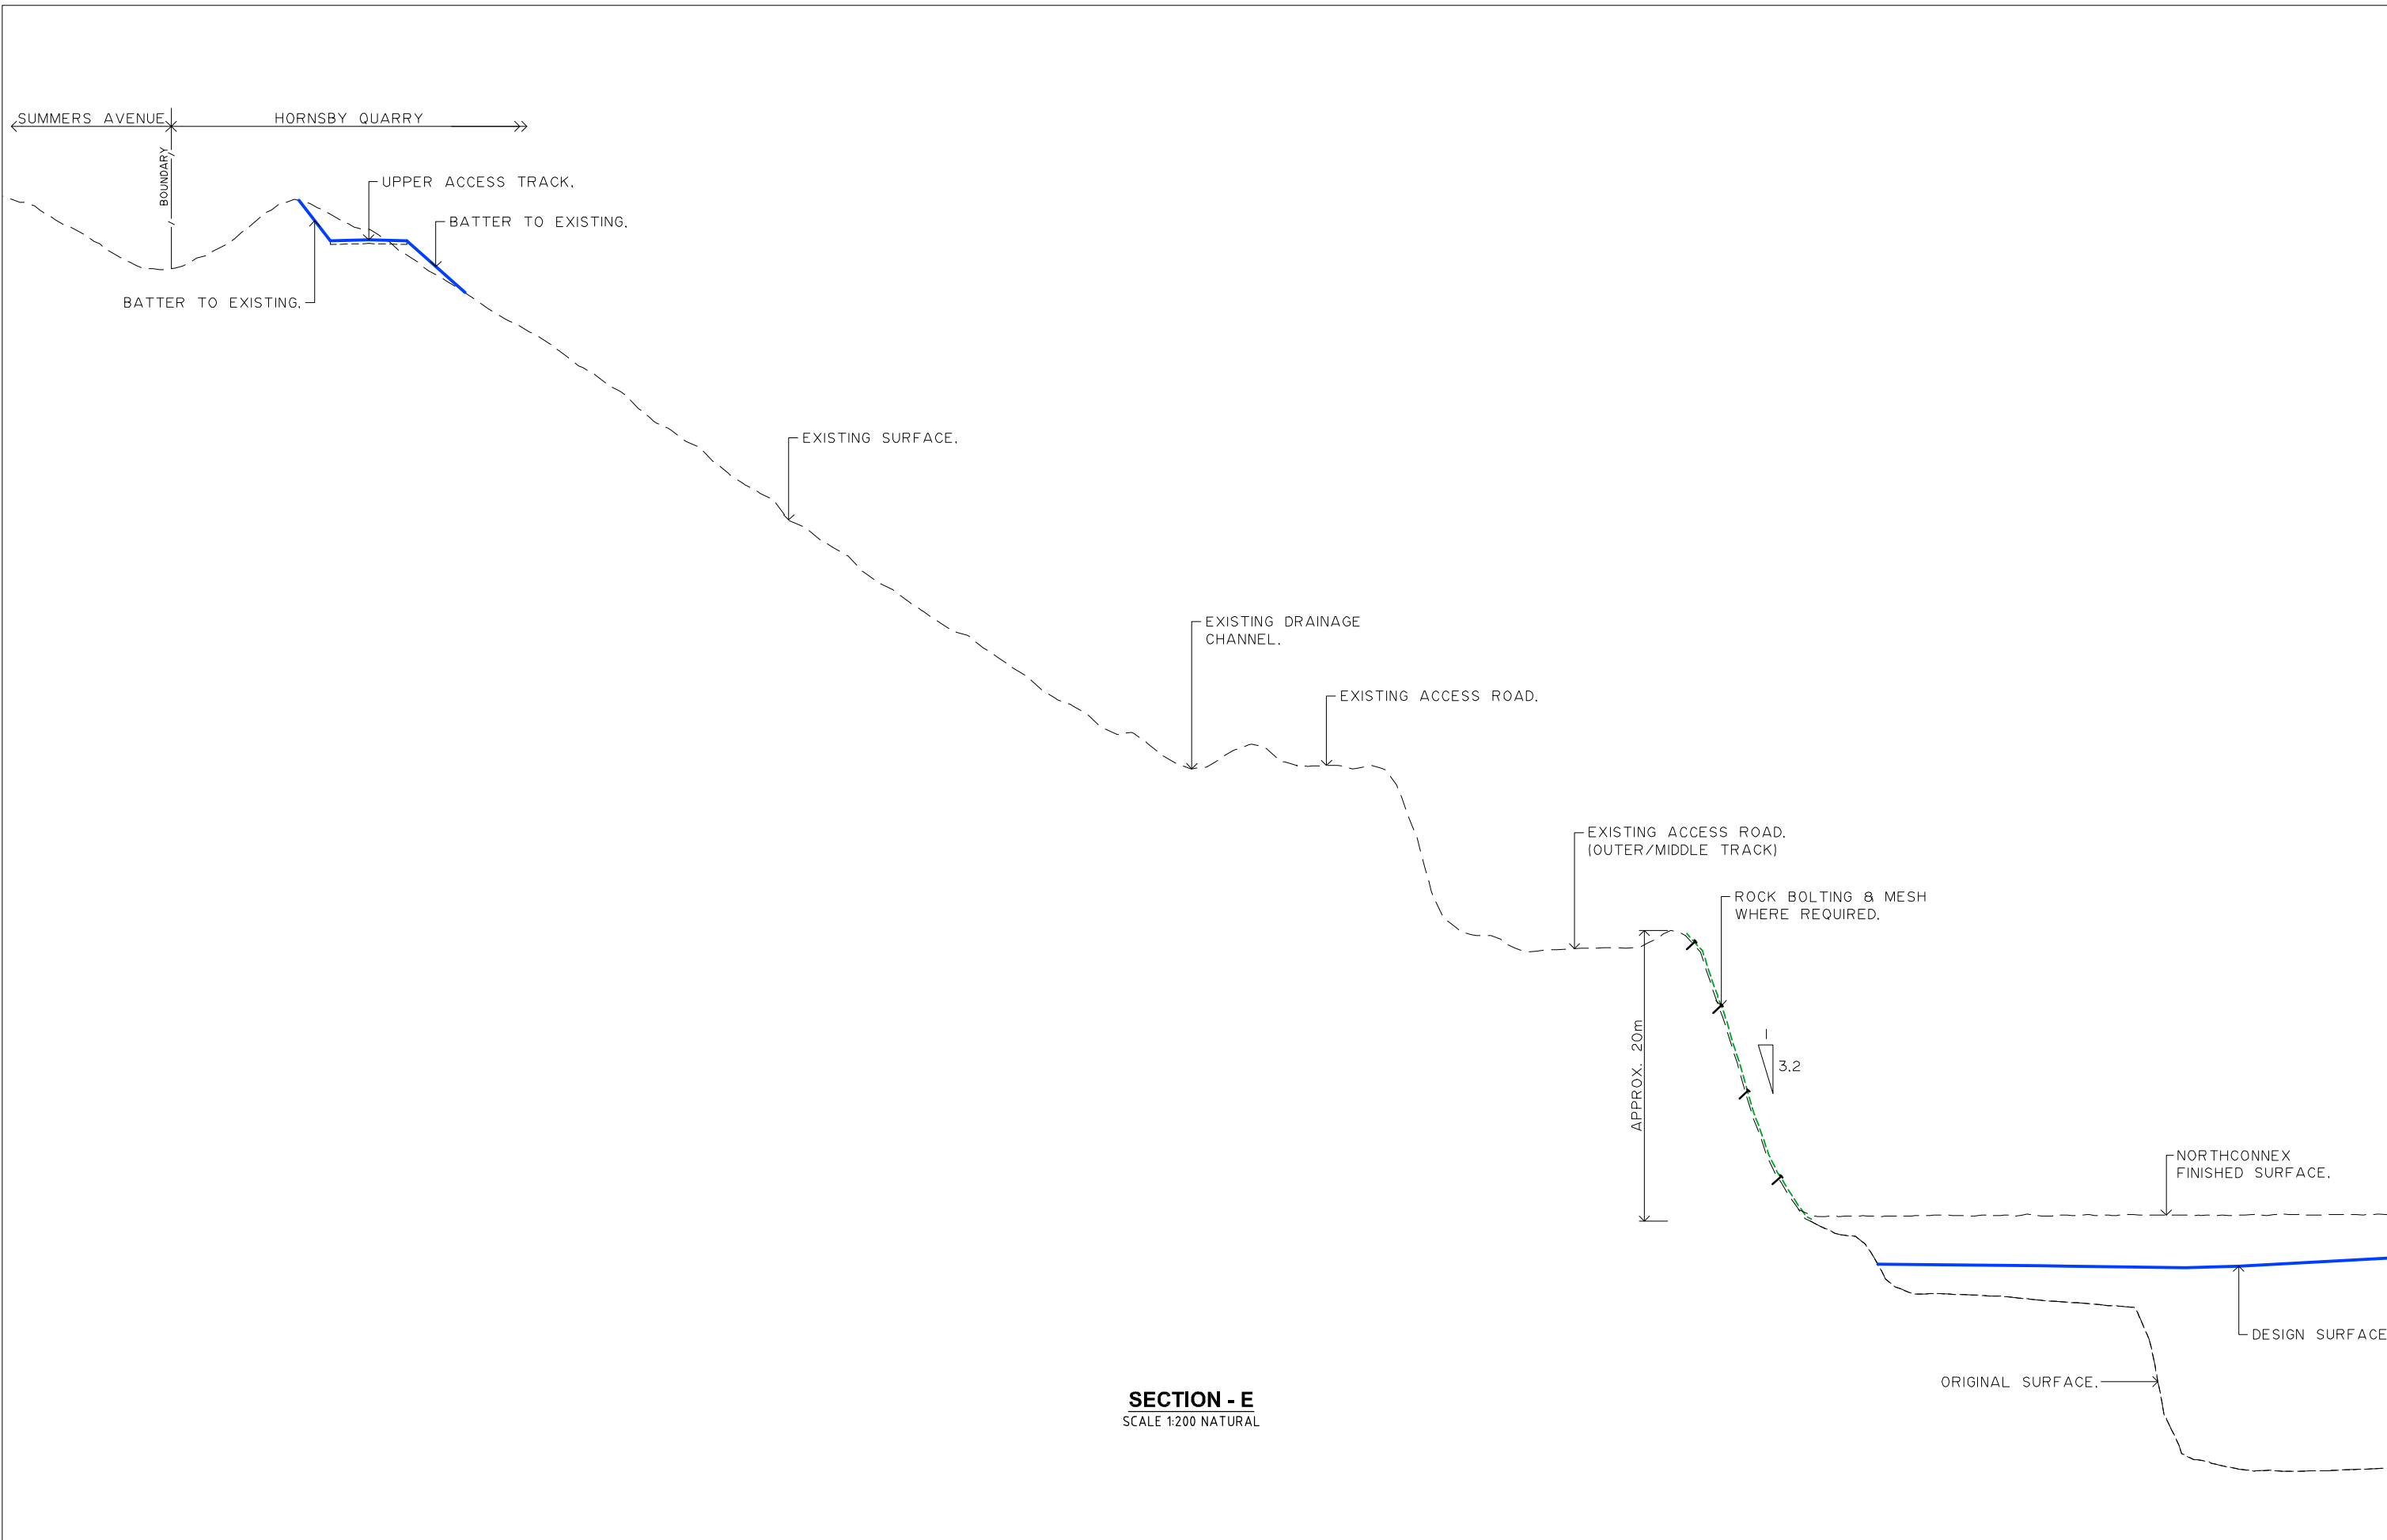
**SECTION - E**  
SCALE 1:200 NATURAL

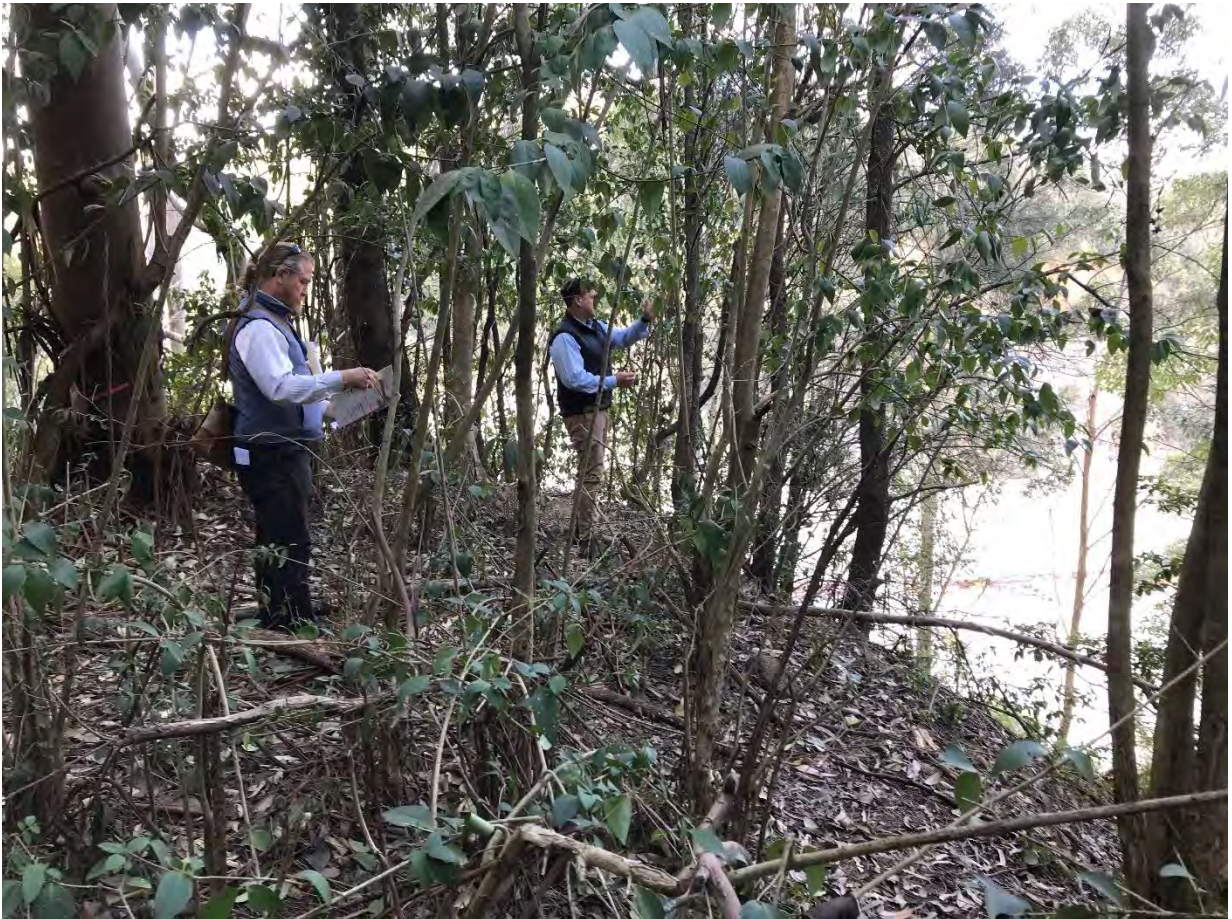
PP03 – MZ1 – Looking south through Privet understorey into the void. Unstable soils within impact area.

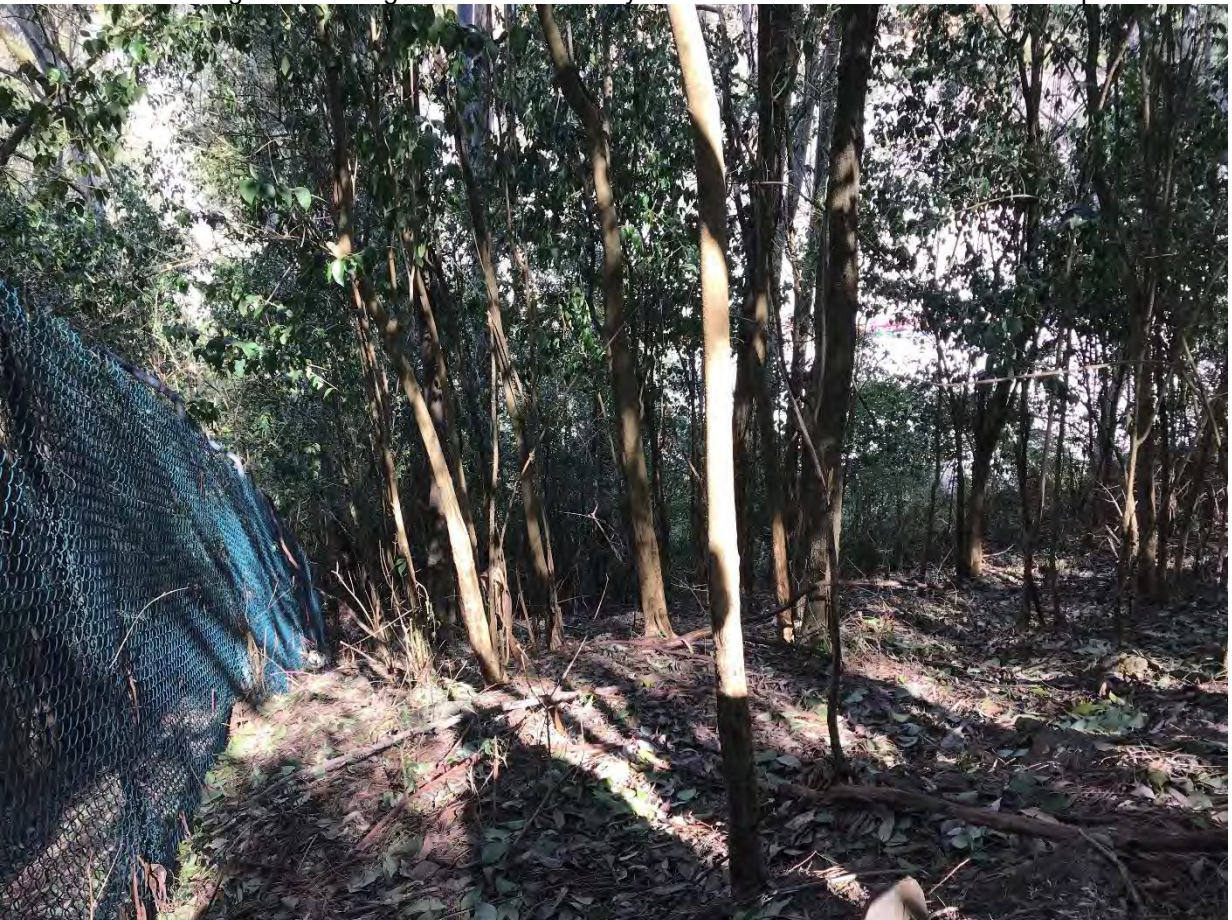
PP03 – MZ1 – Looking south through Privet understorey into the void. Unstable soils within impact area.

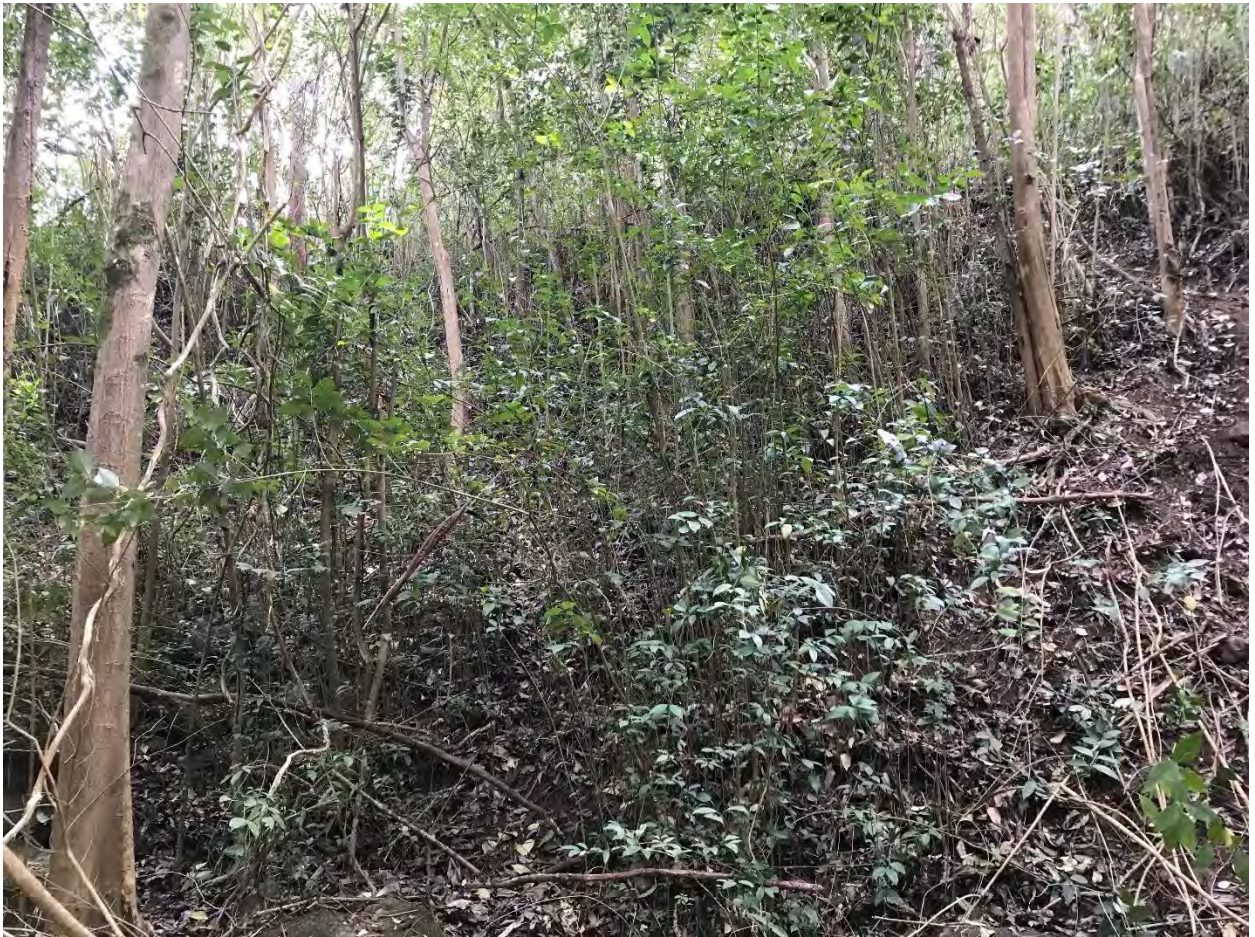
PP04 – MZ1 – Looking north from up slope. Unstable soils within impact area.

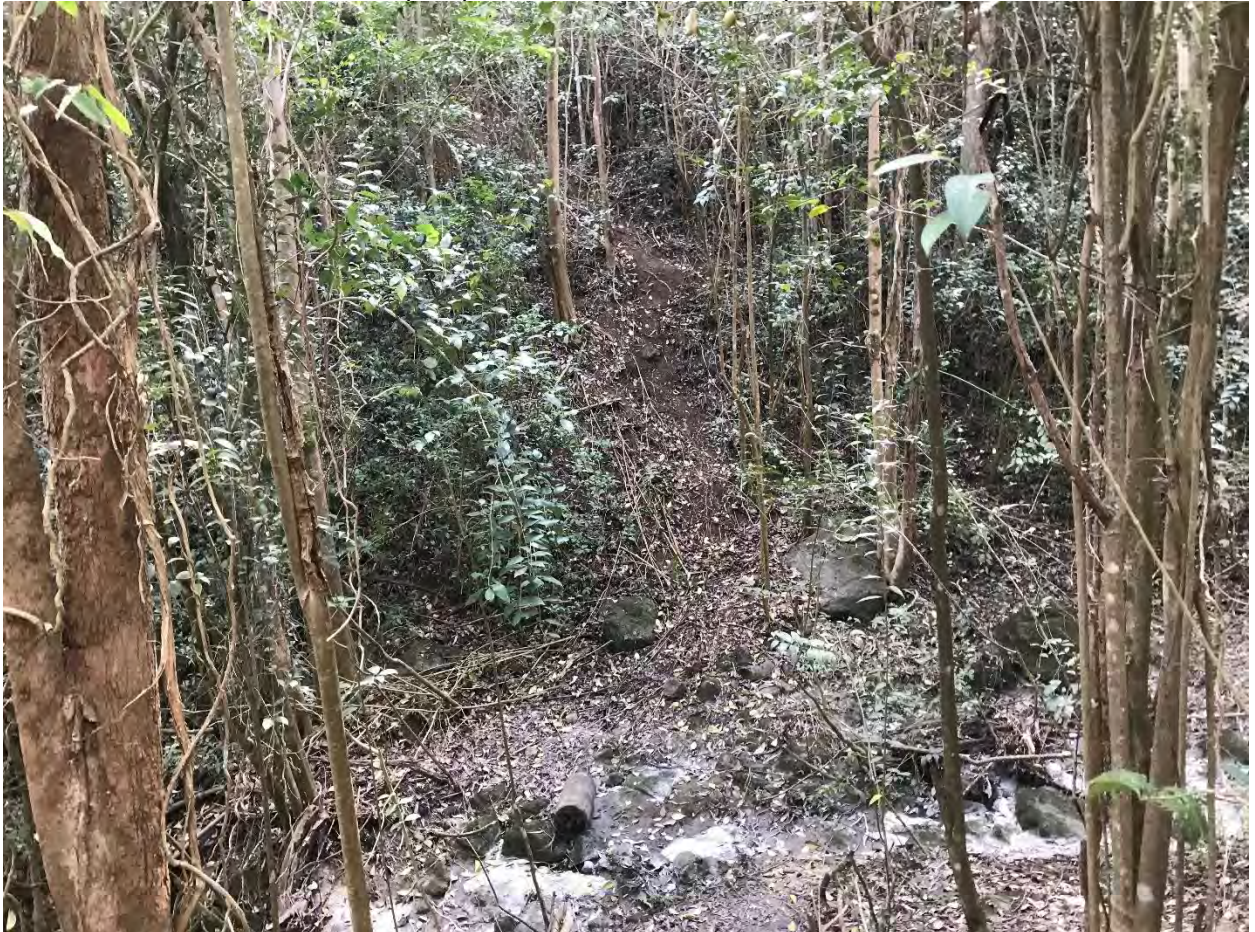
PP04 – MZ1 – Looking north from up slope. Unstable soils within impact area.

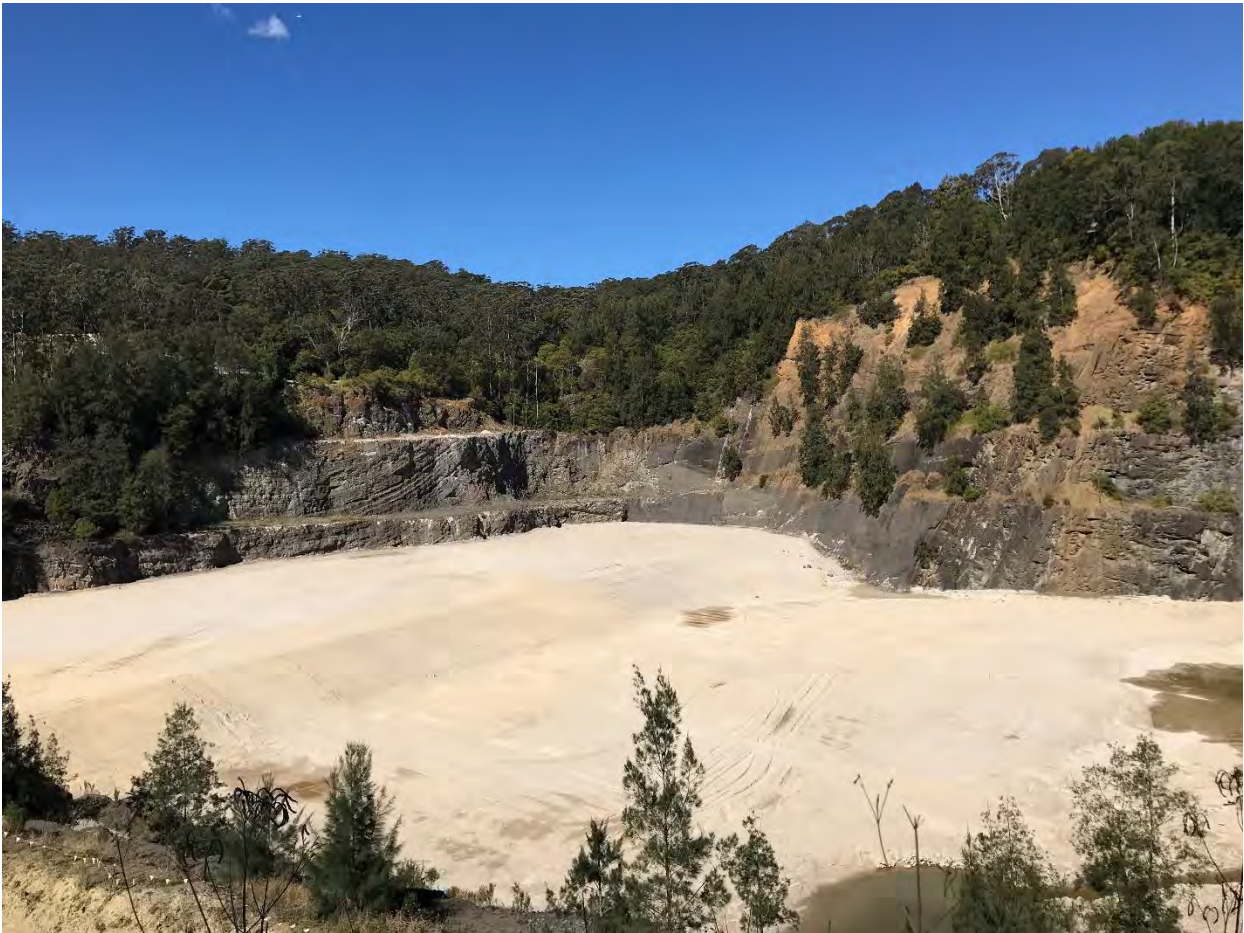
PP78 – MZ3 Partially filled void looking south east

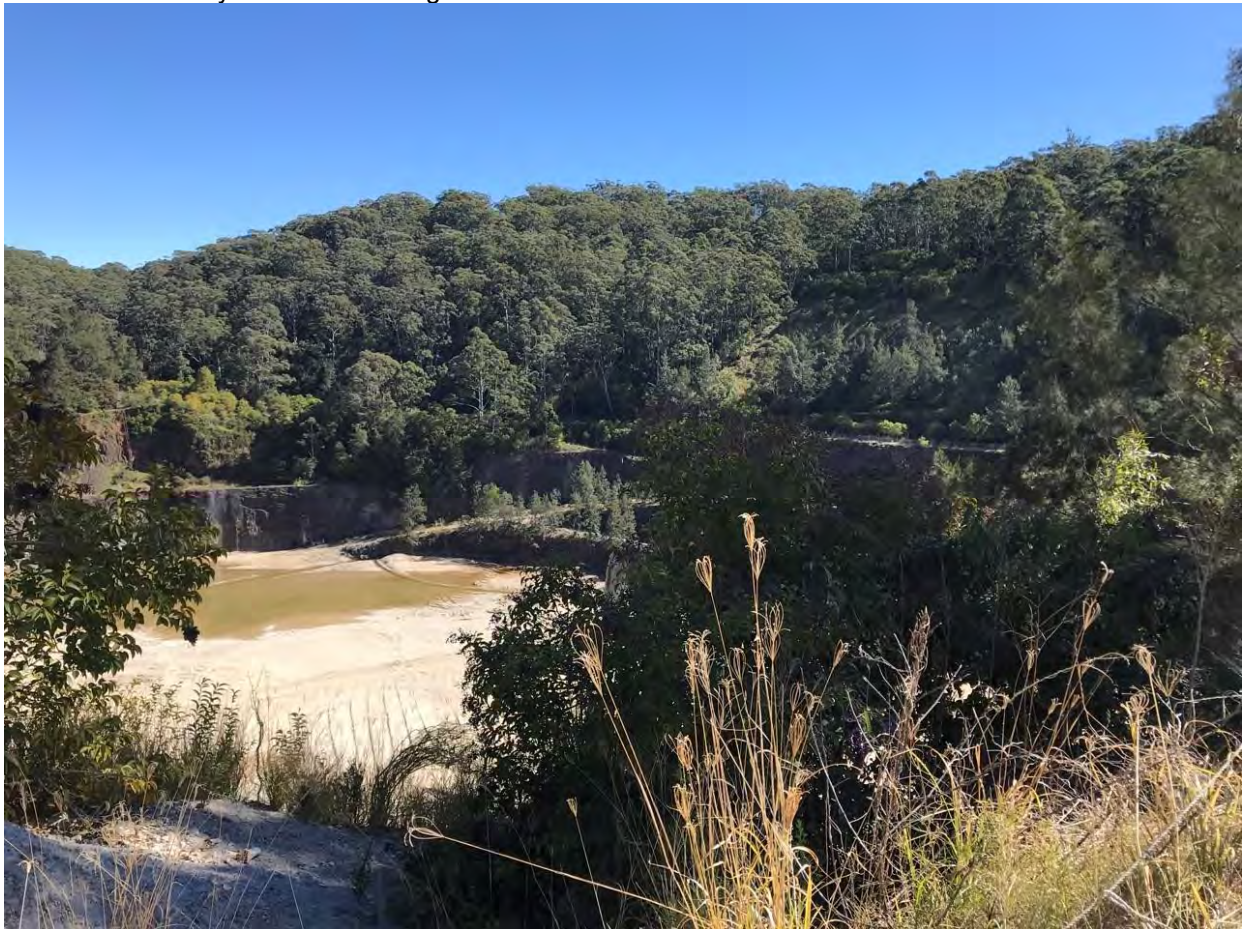
PP74 – MZ3 Partially filled void looking west

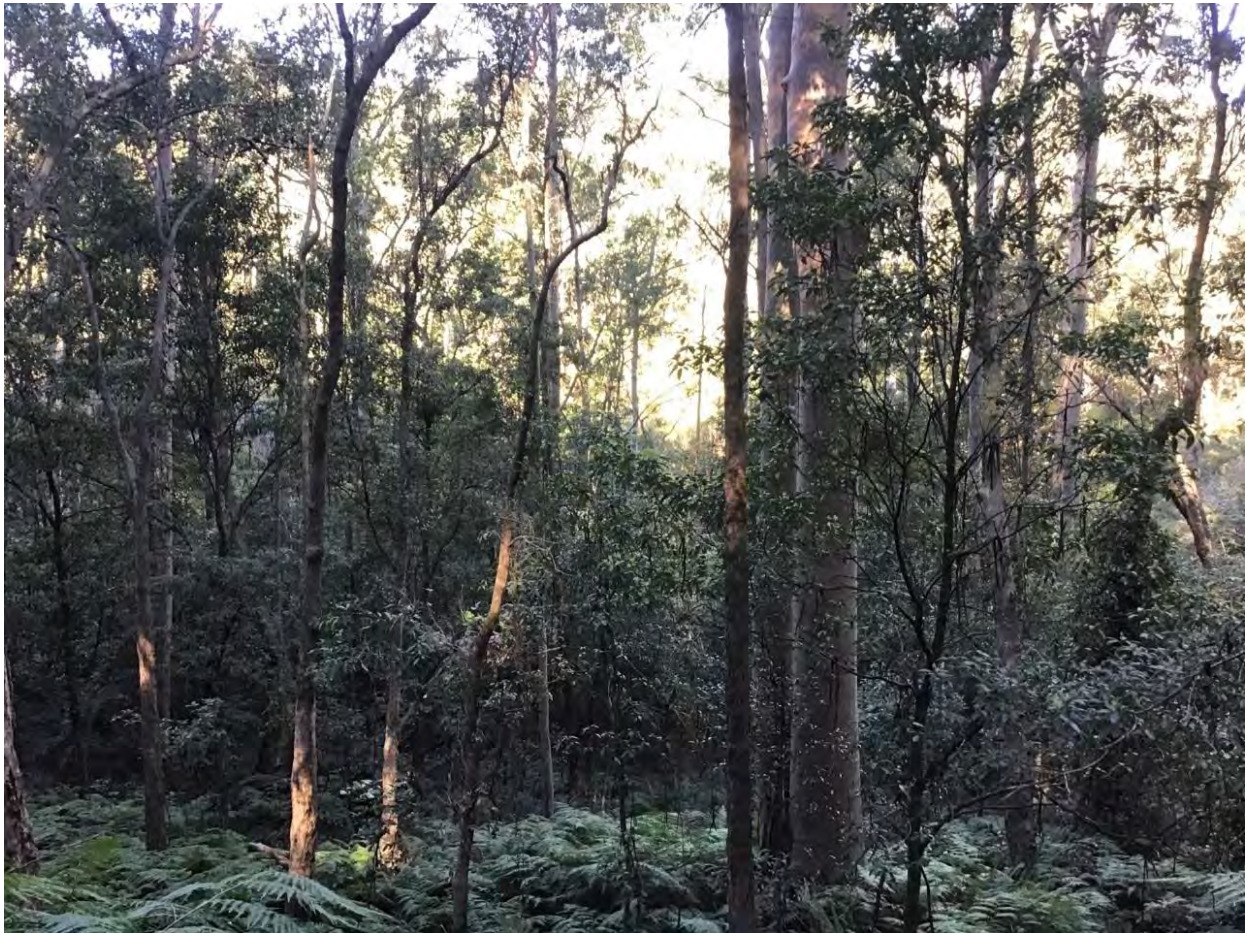
PP11 – In Blue Gum Diatreme Forest looking east to Impact Area. Site of potential Edge Effects.

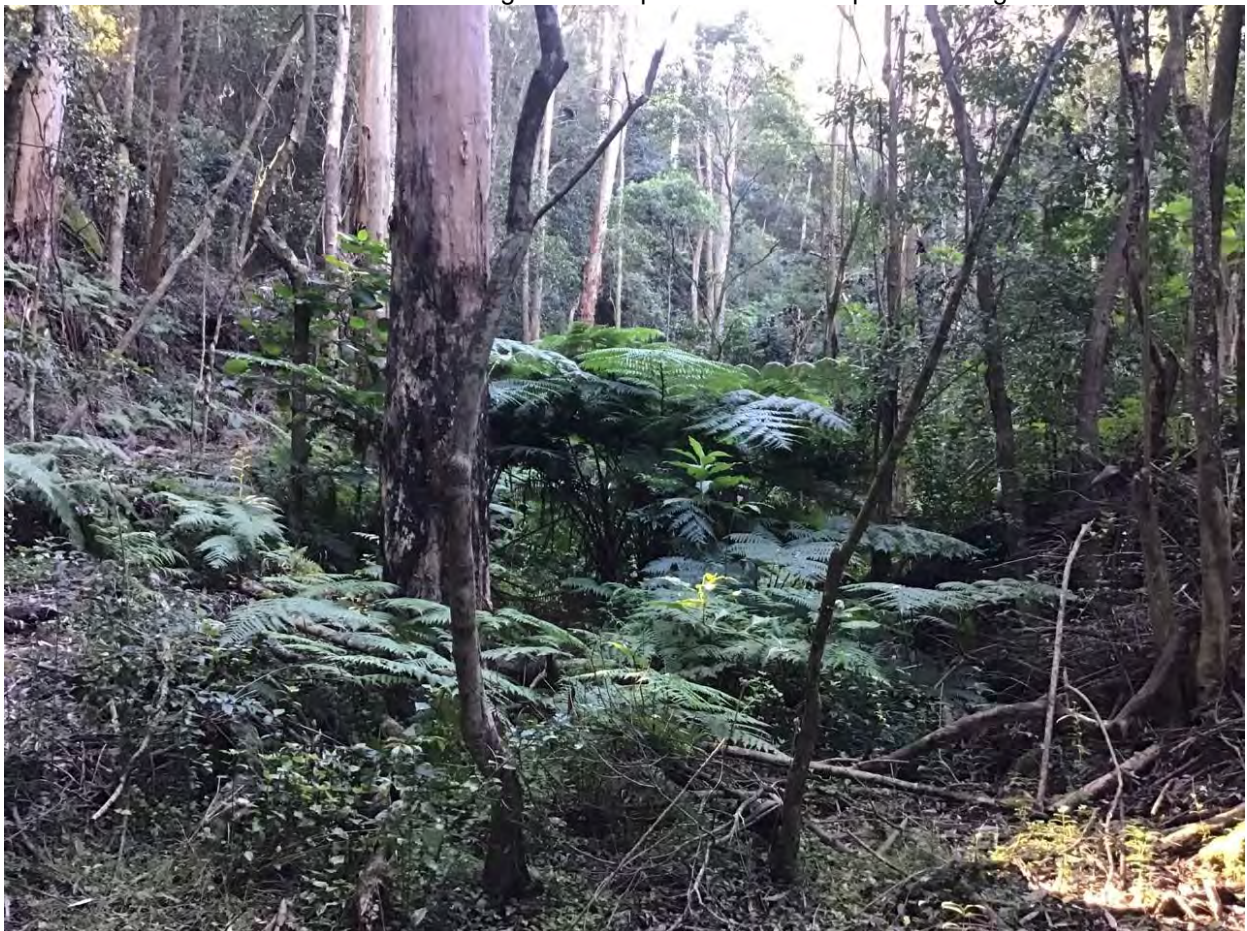
PP18 – Beyond impact area looking north. Modified drainage system.

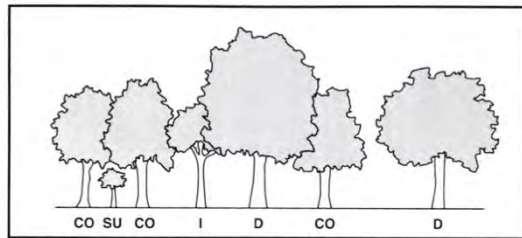
Figure 13. Crown Class is a description of the overall form of the tree as dominant (D), codominant (CO), intermediate (I) or suppressed (SU). Crown class is influenced by the proximity of the tree to other trees. (Adapted from The Hazard Tree Assessment Program, Recreation and Park Dept., City and County of San Francisco)

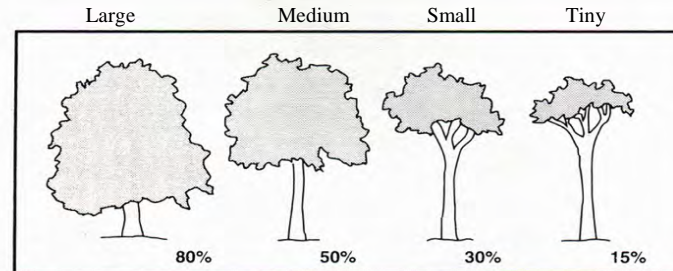
Figure 12. Live Crown Ratio is the ratio of the foliage canopy to the total height of the tree. Trees grown in stands usually have a lower live crown ratio than trees grown in the open.

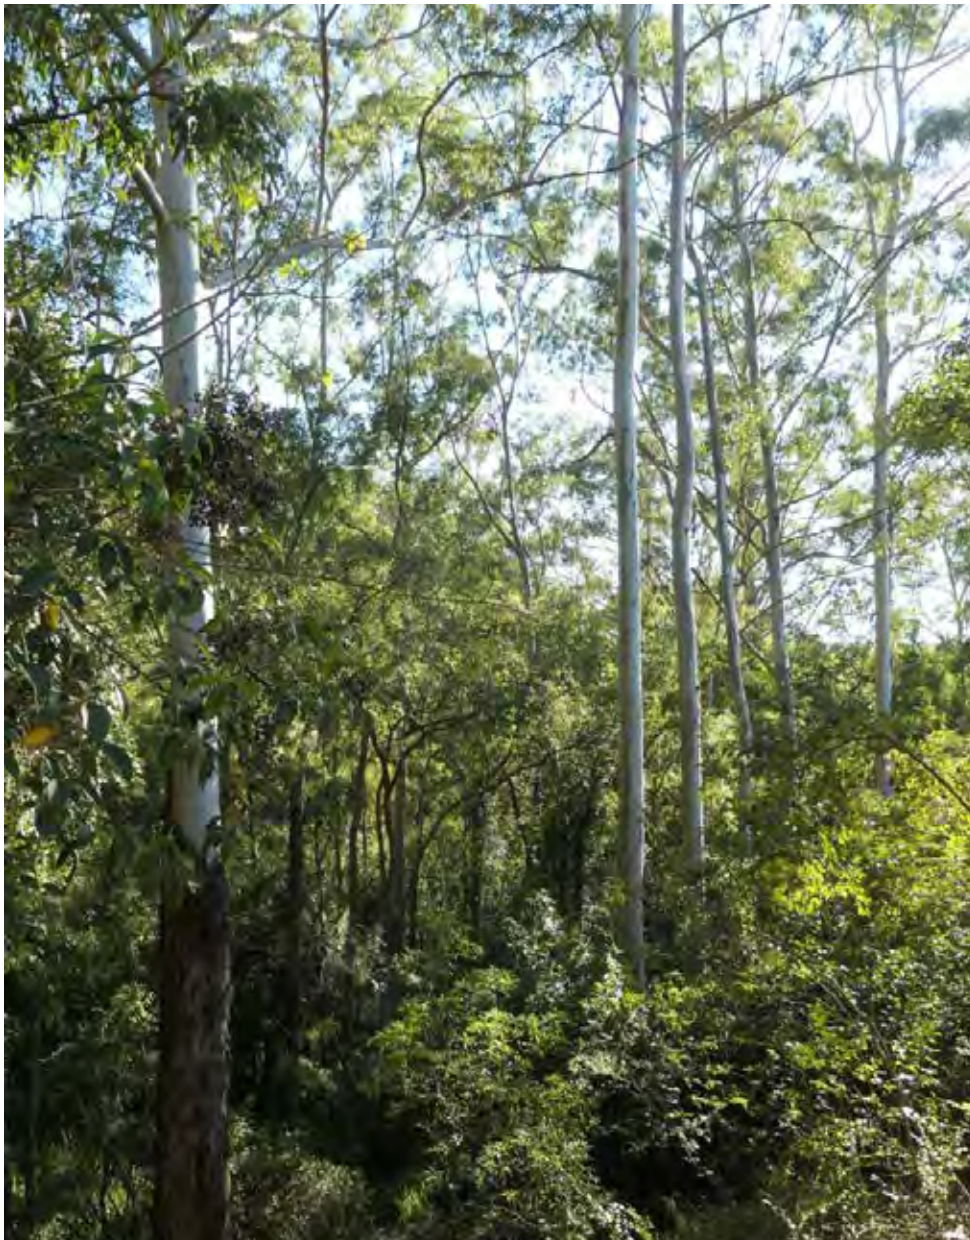
Figure i – View of some Sydney Blue Gums near the southern end of Old Mans Valley, adjacent to the mountain bike pump track that were typical of what is found throughout the survey area. (Photo: Arterra 25 July 2019)

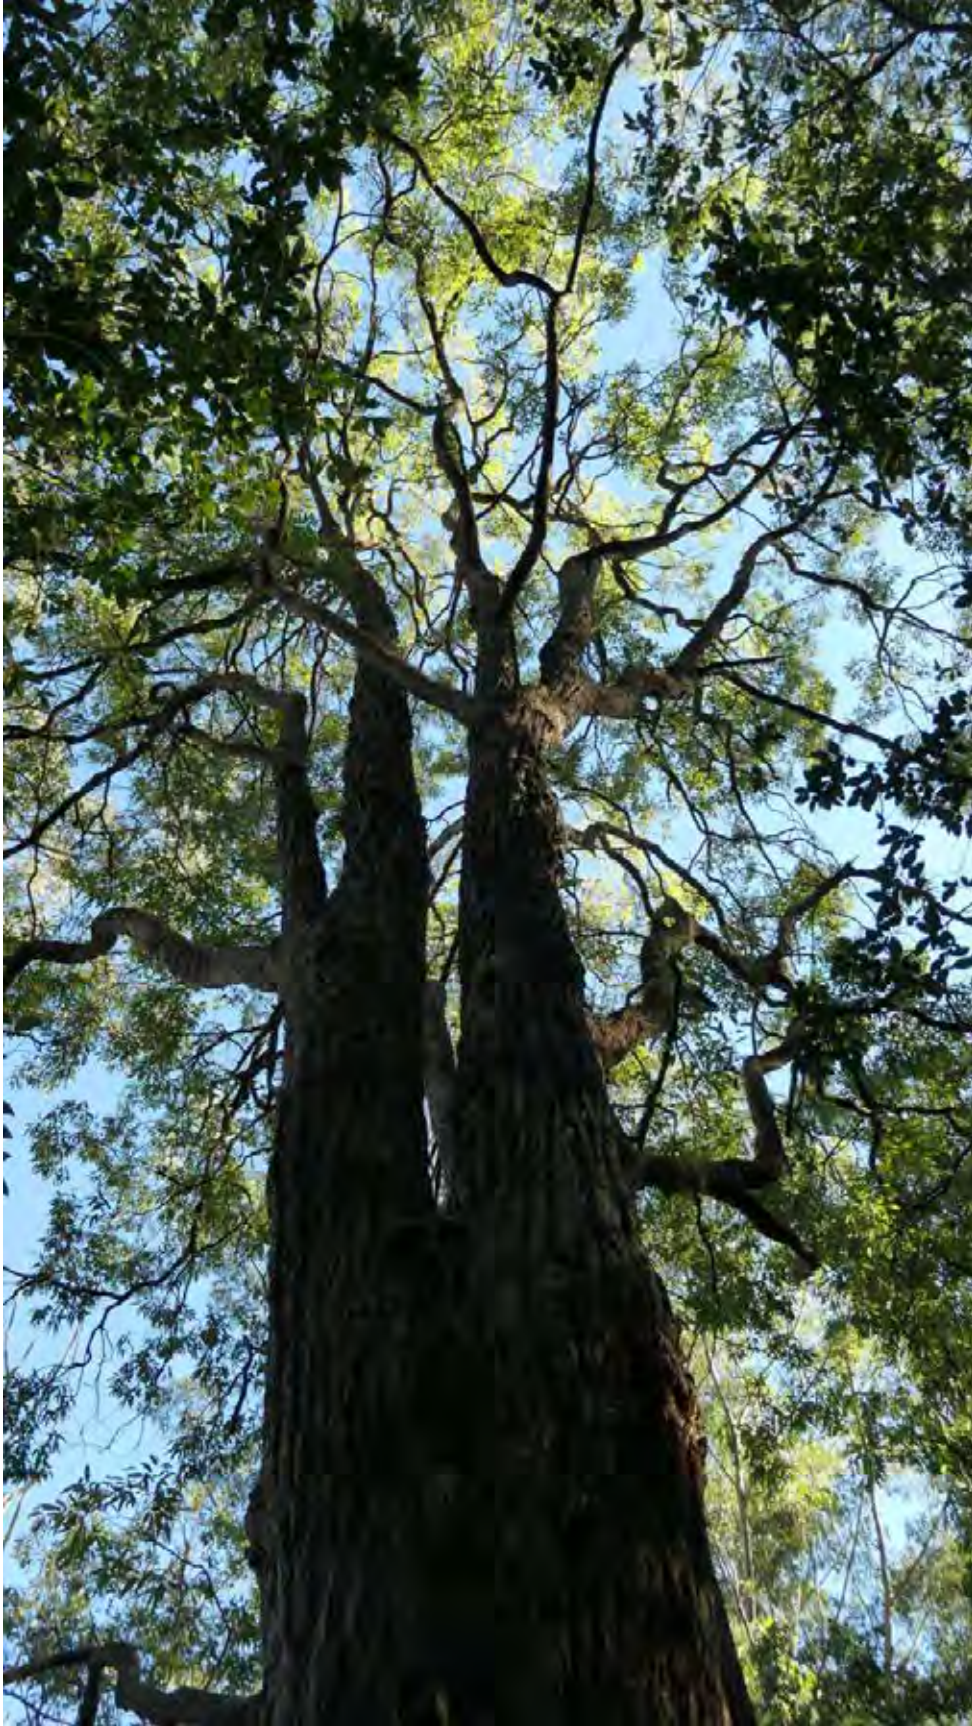
*Figure ii – View of an excellent specimen of an Angophora floribunda (Rough-barked Apple) very common throughout the survey area . (Photo: Arterra 25 July 2019)*

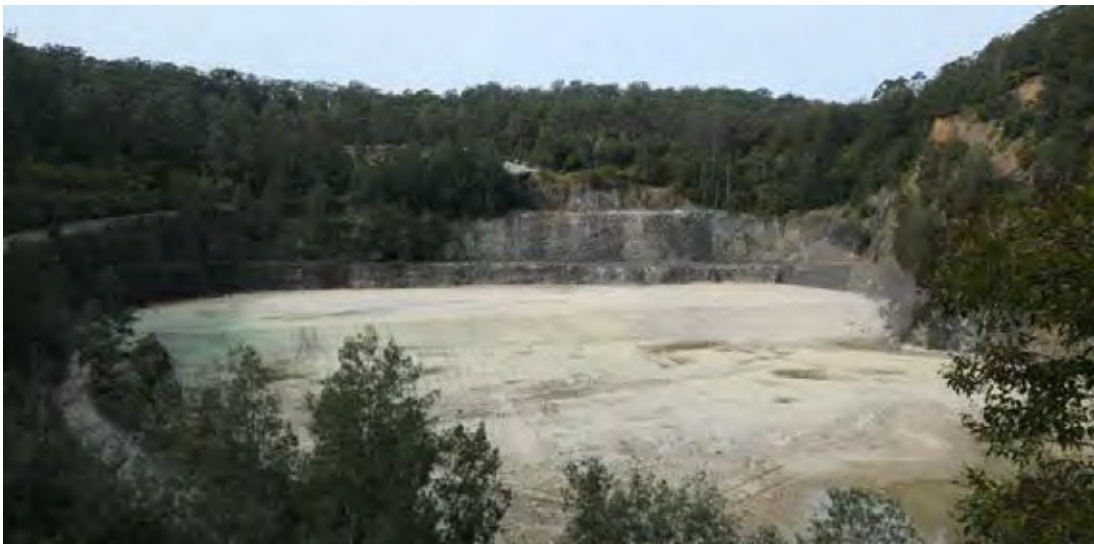
*Figure 1 – View from the western side of the now abandoned Hornsby Quarry looking east towards Old Mans Valley. (Photo: Arterra 25 July 2019)*

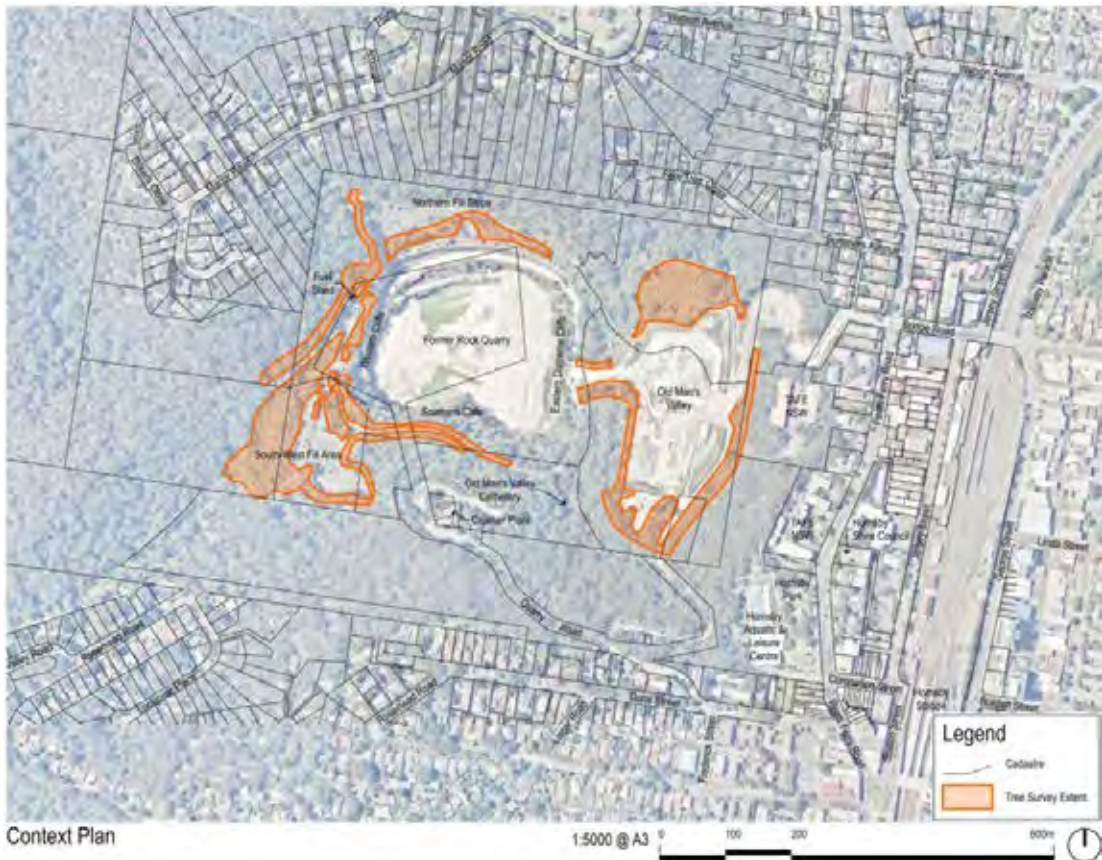
Figure 3 – Site context and demarcation of the 'Tree Survey Area' as identified by Council prior to undertaking the assessment. (Source: Arterra)

It is important to note that the broader Hornsby Quarry site covers approximately 40ha and only a relatively small, 6.4 ha portion site was the subject of this tree survey, assessment and report. The survey extent is shown in Figure 3. As noted, not every tree within the site survey extent was recorded. The trees surveyed had to meet the following criteria:

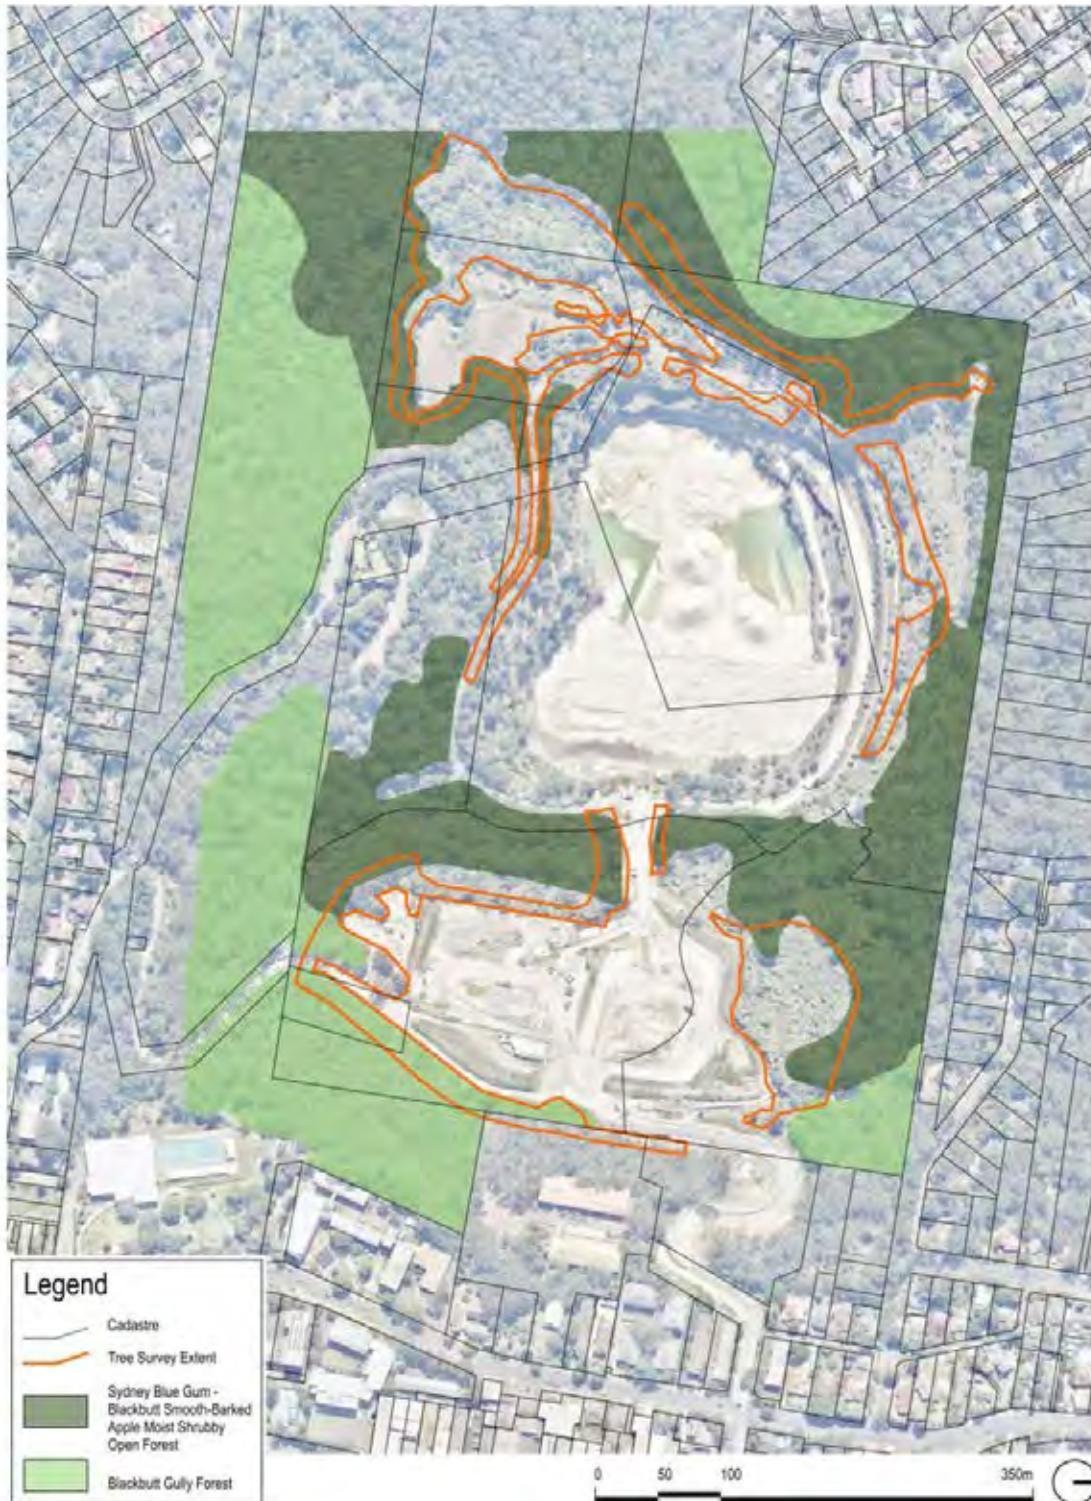
Figure 4 – Context and approximate demarcation of the remaining and surrounding natural vegetation communities and its relationship to the quarry and the identified survey area. (Source: Arterra, adapted from mapping supplied by Hornsby Council)

As per the figure above, the natural vegetation communities that are associated with this area are Blue Gum/Blackbutt/Smooth-barked Apple Moist Shrubby Open Forest and Blackbutt Gully Forest. These are communities that are often more broadly described as Blue Gum High Forest. This is an Endangered Ecological Community under NSW Threatened Species legislation, with less than 5% of its original distribution still remaining. *Eucalyptus saligna* (Sydney Blue Gum) and *Eucalyptus pilularis* (Blackbutt) were the dominant trees, with the Blue Gums favouring the moist lower slopes and Blackbutts more prevalent on the ridges. The mid and understorey tree species would have been dominated by *Angophora costata*, *Angophora floribunda*, *Eucalyptus globoidea*, *Allocasuarina torulosa* and *Syncarpia glomulifera*. (Benson and Howell, 1995).

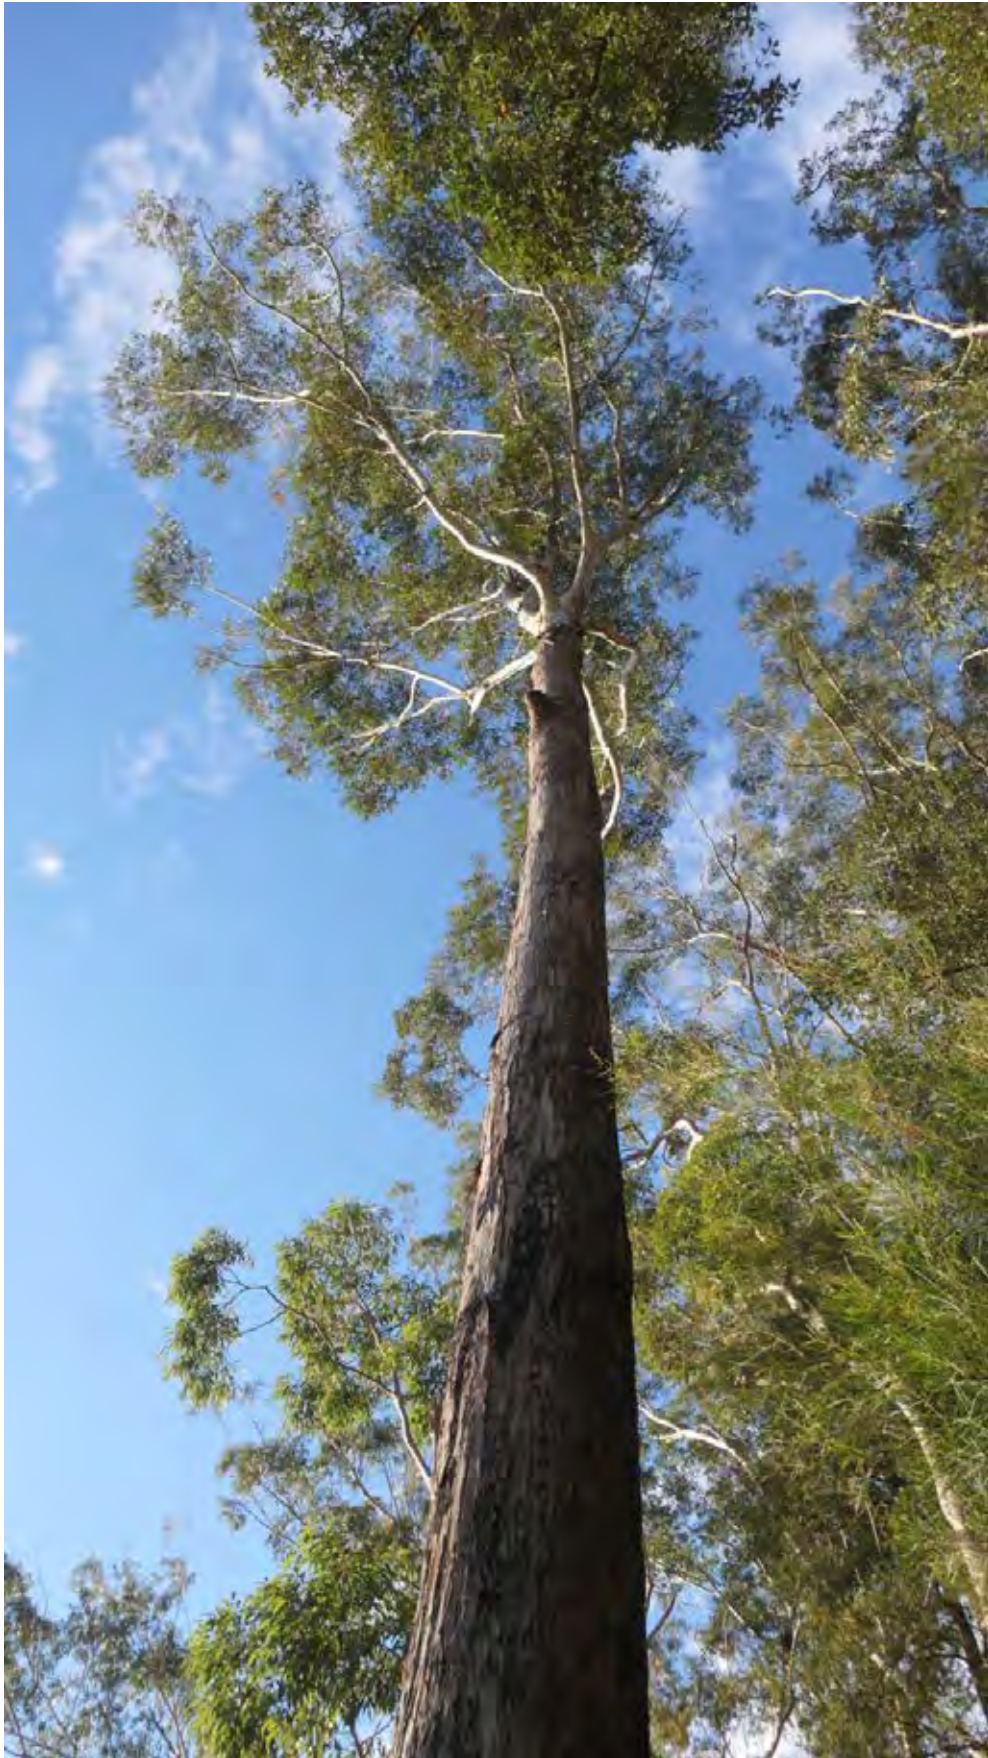
*Figure 5 – The site contains numerous significant and impressive endemic trees such as this Blackbutt (*Euc. pilularis*) which often stand well in excess of 35m tall and with trunk diameters close to 1m at ground level. These older trees often provide significant habitat with numerous small hollows and spouts that would support native wildlife. (Photo: Arterra 25 July 2019)*

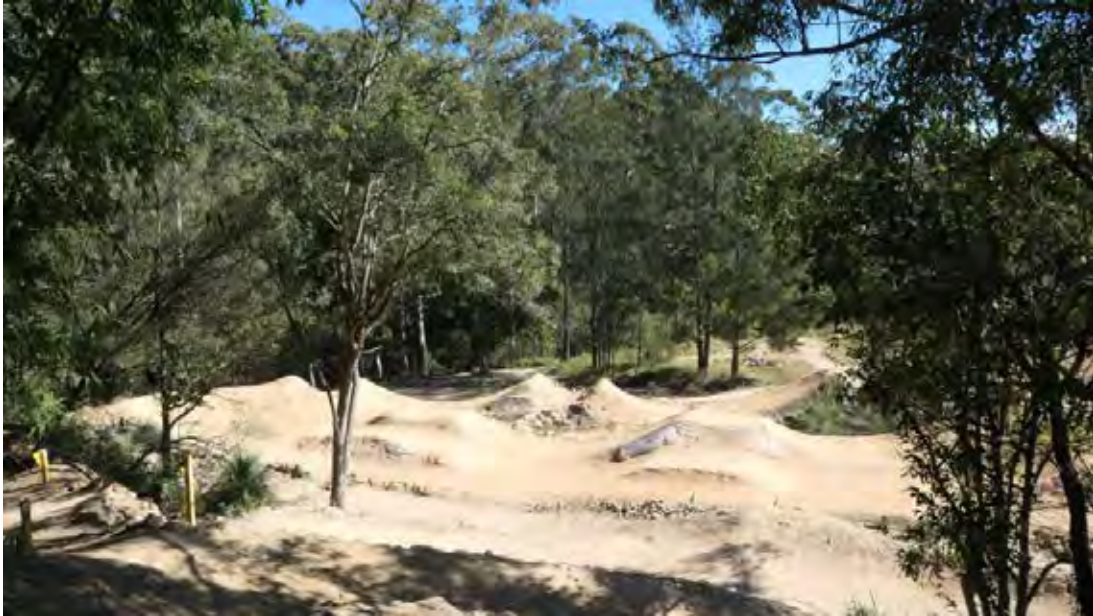
*Figure 6 – View of the mountain bike ‘pump track’ located to the southern end of the Old Man’s Valley fill area. This is part of a far more extensive mount bike trail network that surrounds much of the quarry site. Trees are often intimately related to the extensive trail network. (Photo: Arterra 22 July 2019)*
