## Hornsby Shire Council

Hornsby Quarry Rehabilitation works including bulk earthworks (and associated civil works including construction of access tracks, drainage and retaining walls), site remediation, tree removal, revegetation work and site rehabilitation

Response to Submissions and Revised Project Scope

**VOLUME 2 – APPENDICES A to H**

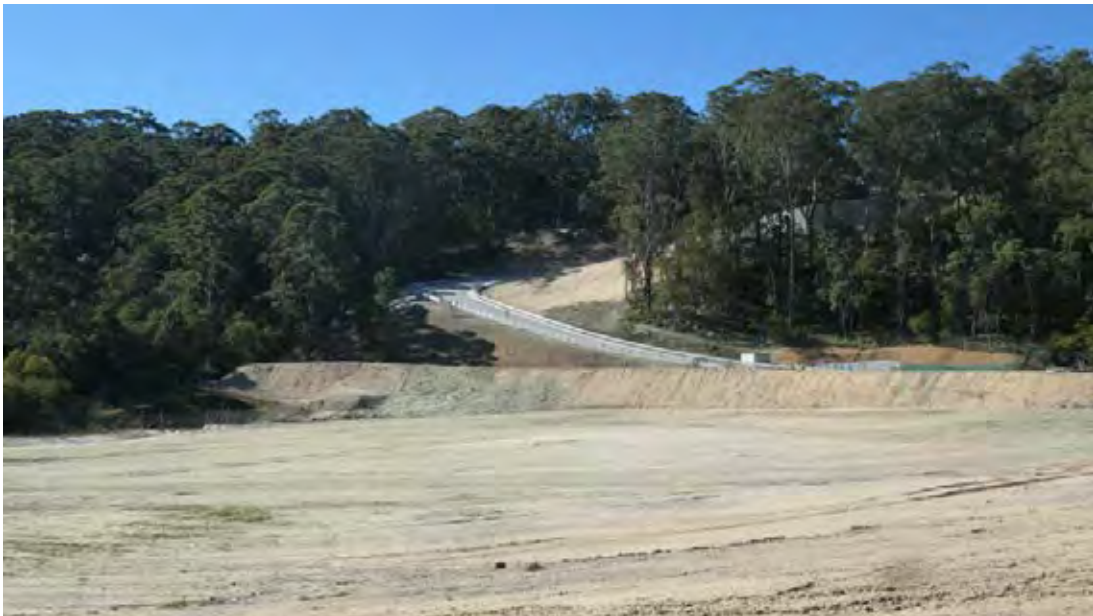
*Figure 7 – View of the northern end of the Old Man’s Valley fill area and the newly constructed driveway leading to Bridge Road. (Photo: Arterra 22 July 2019)*

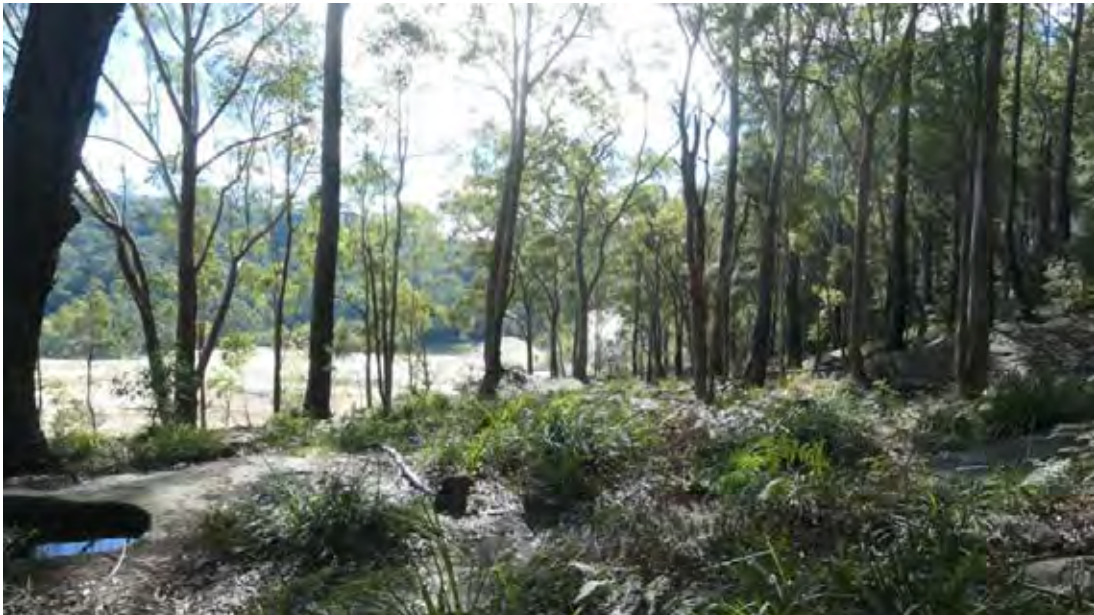
*Figure 8 – Old Man's Valley - view northwest along forested eastern site boundary. Note the historical 'baby bath' carved into the rock adjacent T28 at the far left. (Photo: Arterra 22/7/19)*

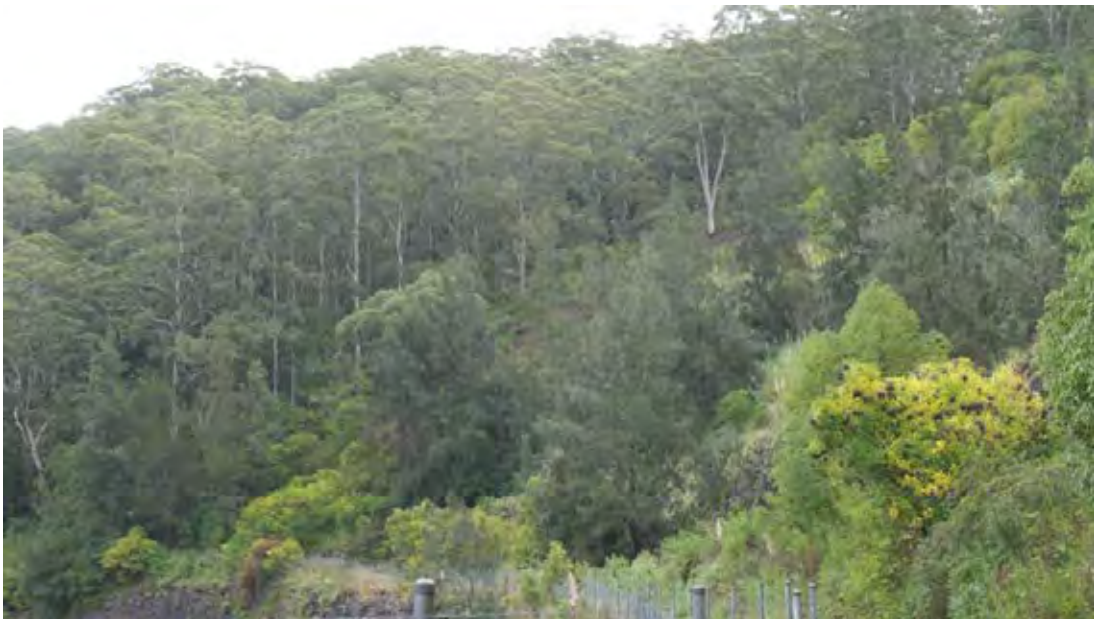
*Figure 9 – Northern fill slopes - at right and view to western edge of the fill slope and its interface with the more natural vegetation of the Blue Gum and Blackbutt Gully Forest beyond. (Photo: Arterra 25/7/19)*

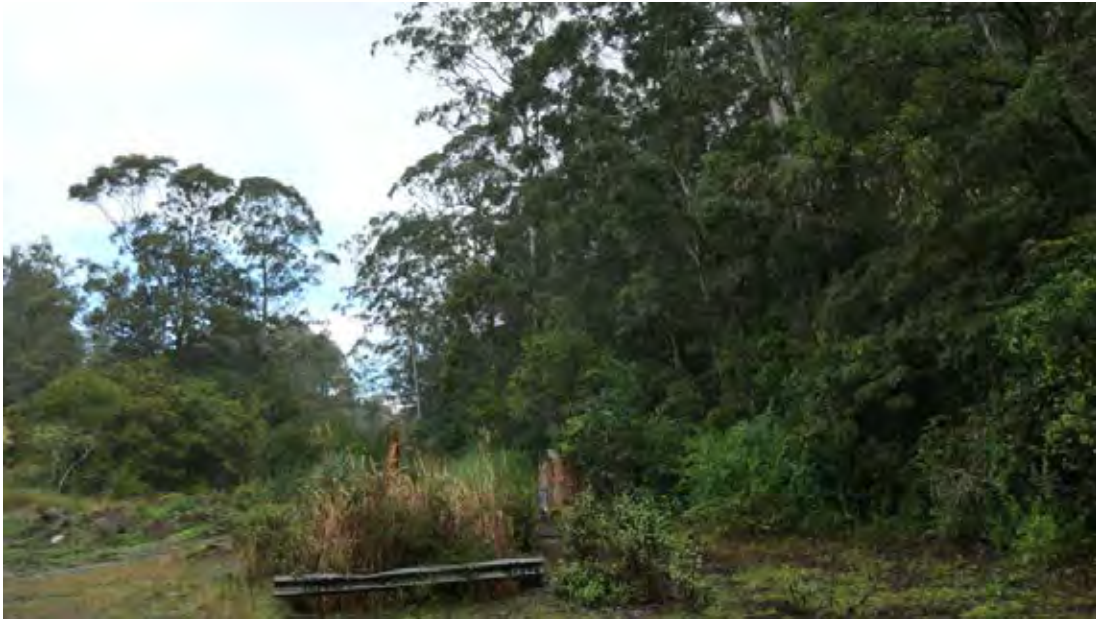
Figure 10 – **Western slopes** at the right, view southwest from the fuel depot towards Rosemead Reserve. (Photo: Arterra 25/6/19)

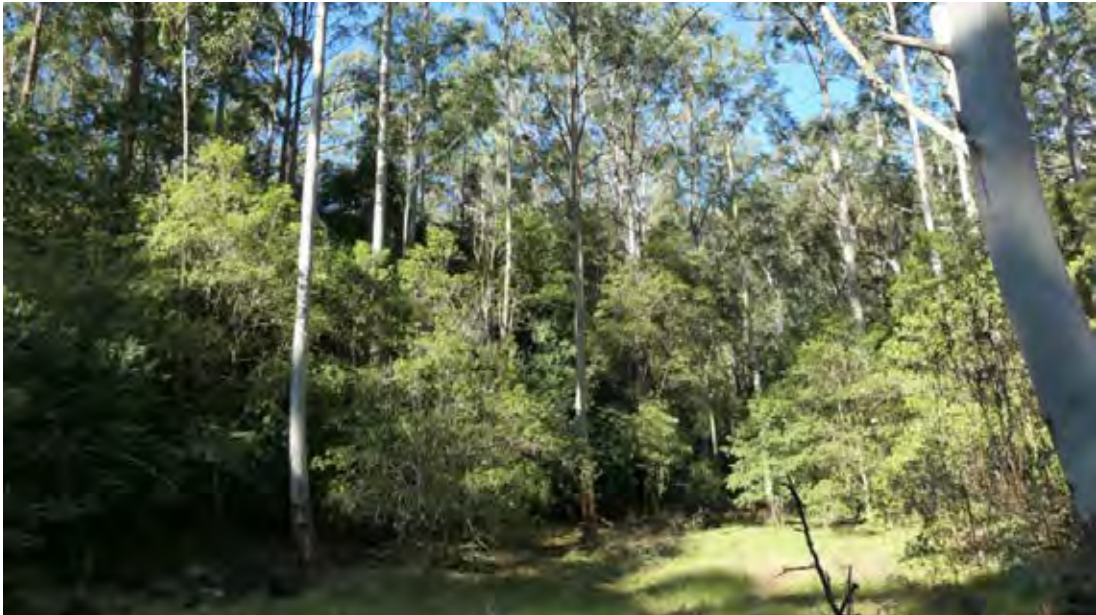
Figure 11 – **South-west fill area** – View east from the toe of the fill bank in Rosemead Reserve looking back towards the south-west fill embankments. (Photo: Arterra 27/7/19)

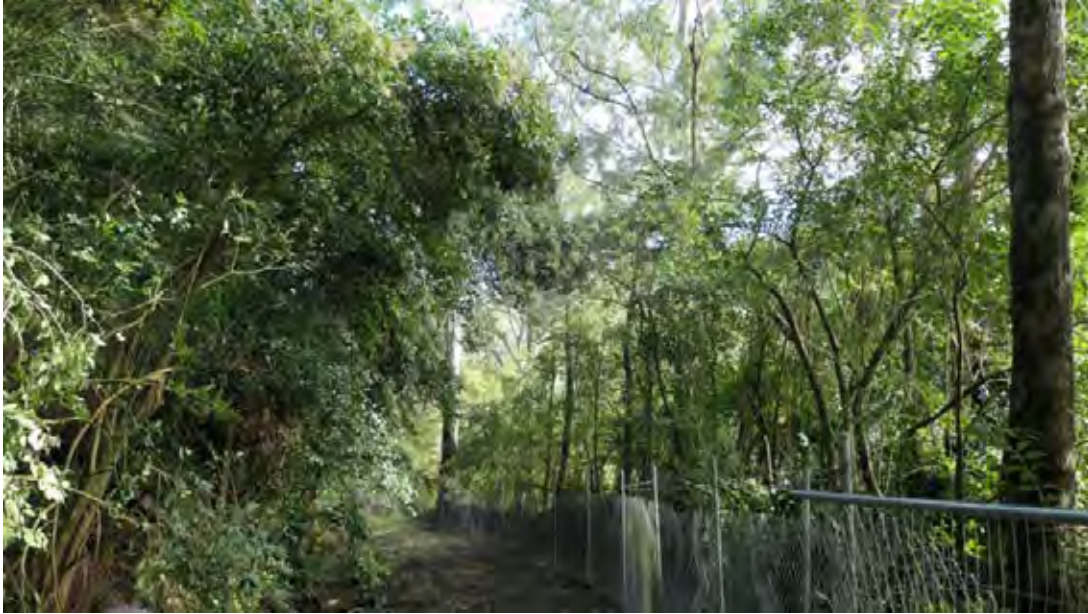
Figure 12 – *Southern Cliffs access road*. View west from the top gate towards the southwest fill area. (Photo: Arterra 25/6/19)

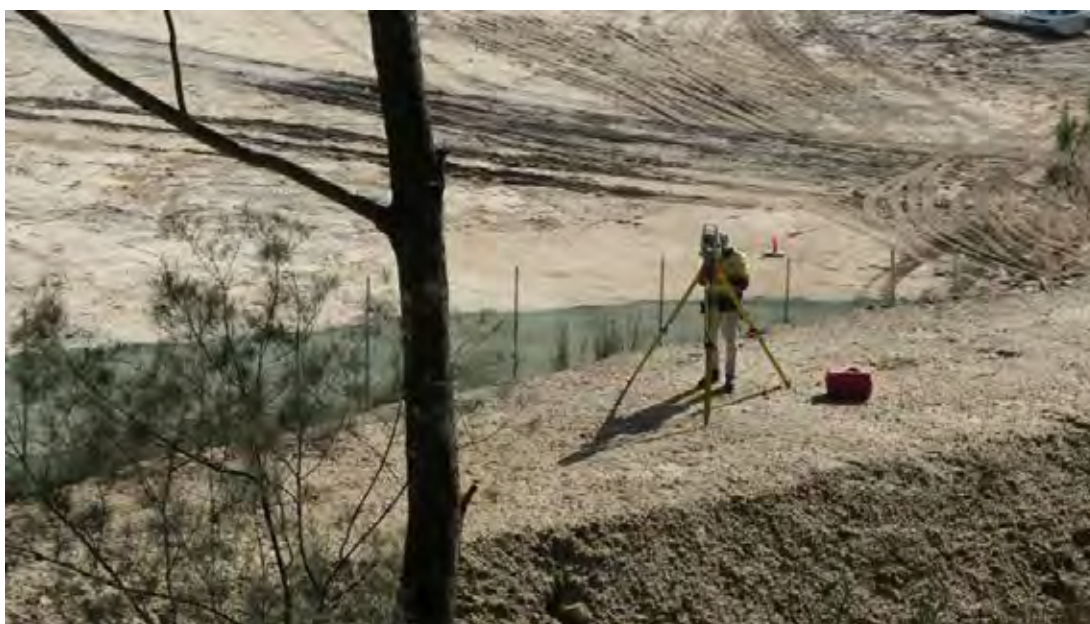
*Figure 13 – Photo illustrating that the trees were surveyed using a registered surveyor to accurately position the trees spatially on the site. This was done at the same time as the trees were surveyed and identified by the arborist to maintain consistency, accuracy of recording and numbering throughout. (Photo: Arterra 22/7/19)*

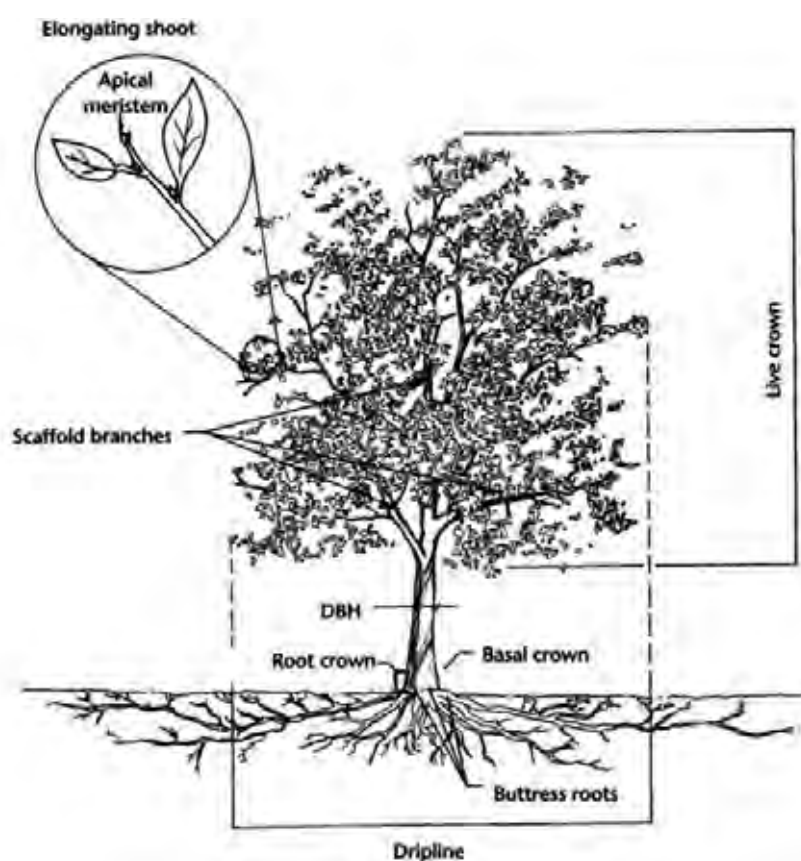
Figure 19 – Typical form and structure of a tree illustrating the typical form, location and extent of root growth (Source: Matheny and Clark, 1998)

Trees are dynamic living organisms. Trees can be very susceptible to damage, stress and declining rapidly if overly impacted by construction. Trees take decades to grow but can be injured and killed in a very short time frame. This is particularly due to the irreparable damage to the often shallow, extensive and unseen root systems. It is rarely possible to repair a stressed or damaged tree, after the damage has occurred. Proper protection is the key. Severing of roots within the Structural Root Zone (SRZ) can also lead to potentially unsafe instability of the tree as a structure.

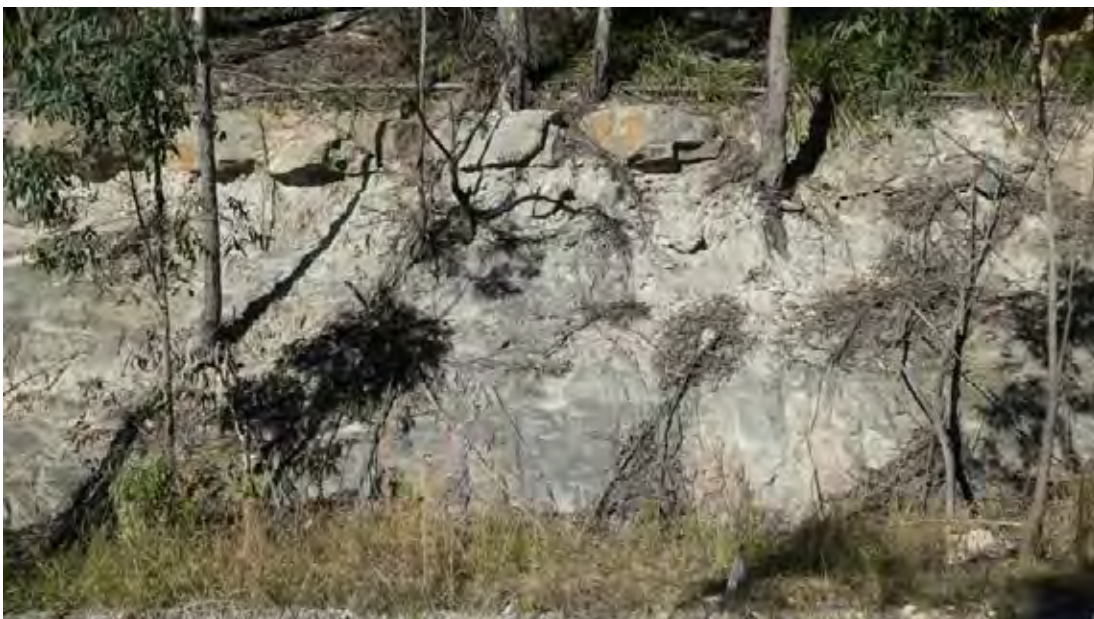
*Figure 20 – Photo illustrating tree root development in extreme environments such as on cliffs or steep embankments may be very atypical and not confirm to normal circular and nominal TPZs. Once the exact nature or earthworks and disturbances are known it may be necessary to undertake more site specific analysis of individual trees that are desired to be retained and protected. (Photo: Arterra 25/7/19)*

It is important to note that for many of the trees observed, traditional and nominal Tree Protection Zones may not strictly apply, as they would normally for more traditional forest trees or urban parkland trees. Many trees are growing in rather extreme and very disturbed environments. Others are also growing in naturally rocky conditions with minimal soils, that is common for this type of geology, and therefore root developments can be very 'atypical'. For example, trees growing in a very rocky or cliff like surroundings may have roots that are totally to one side of the tree and expanding throughout extensive rock crevices and fissures. The extent and nature of the root development in this environment would be very difficult to predict.

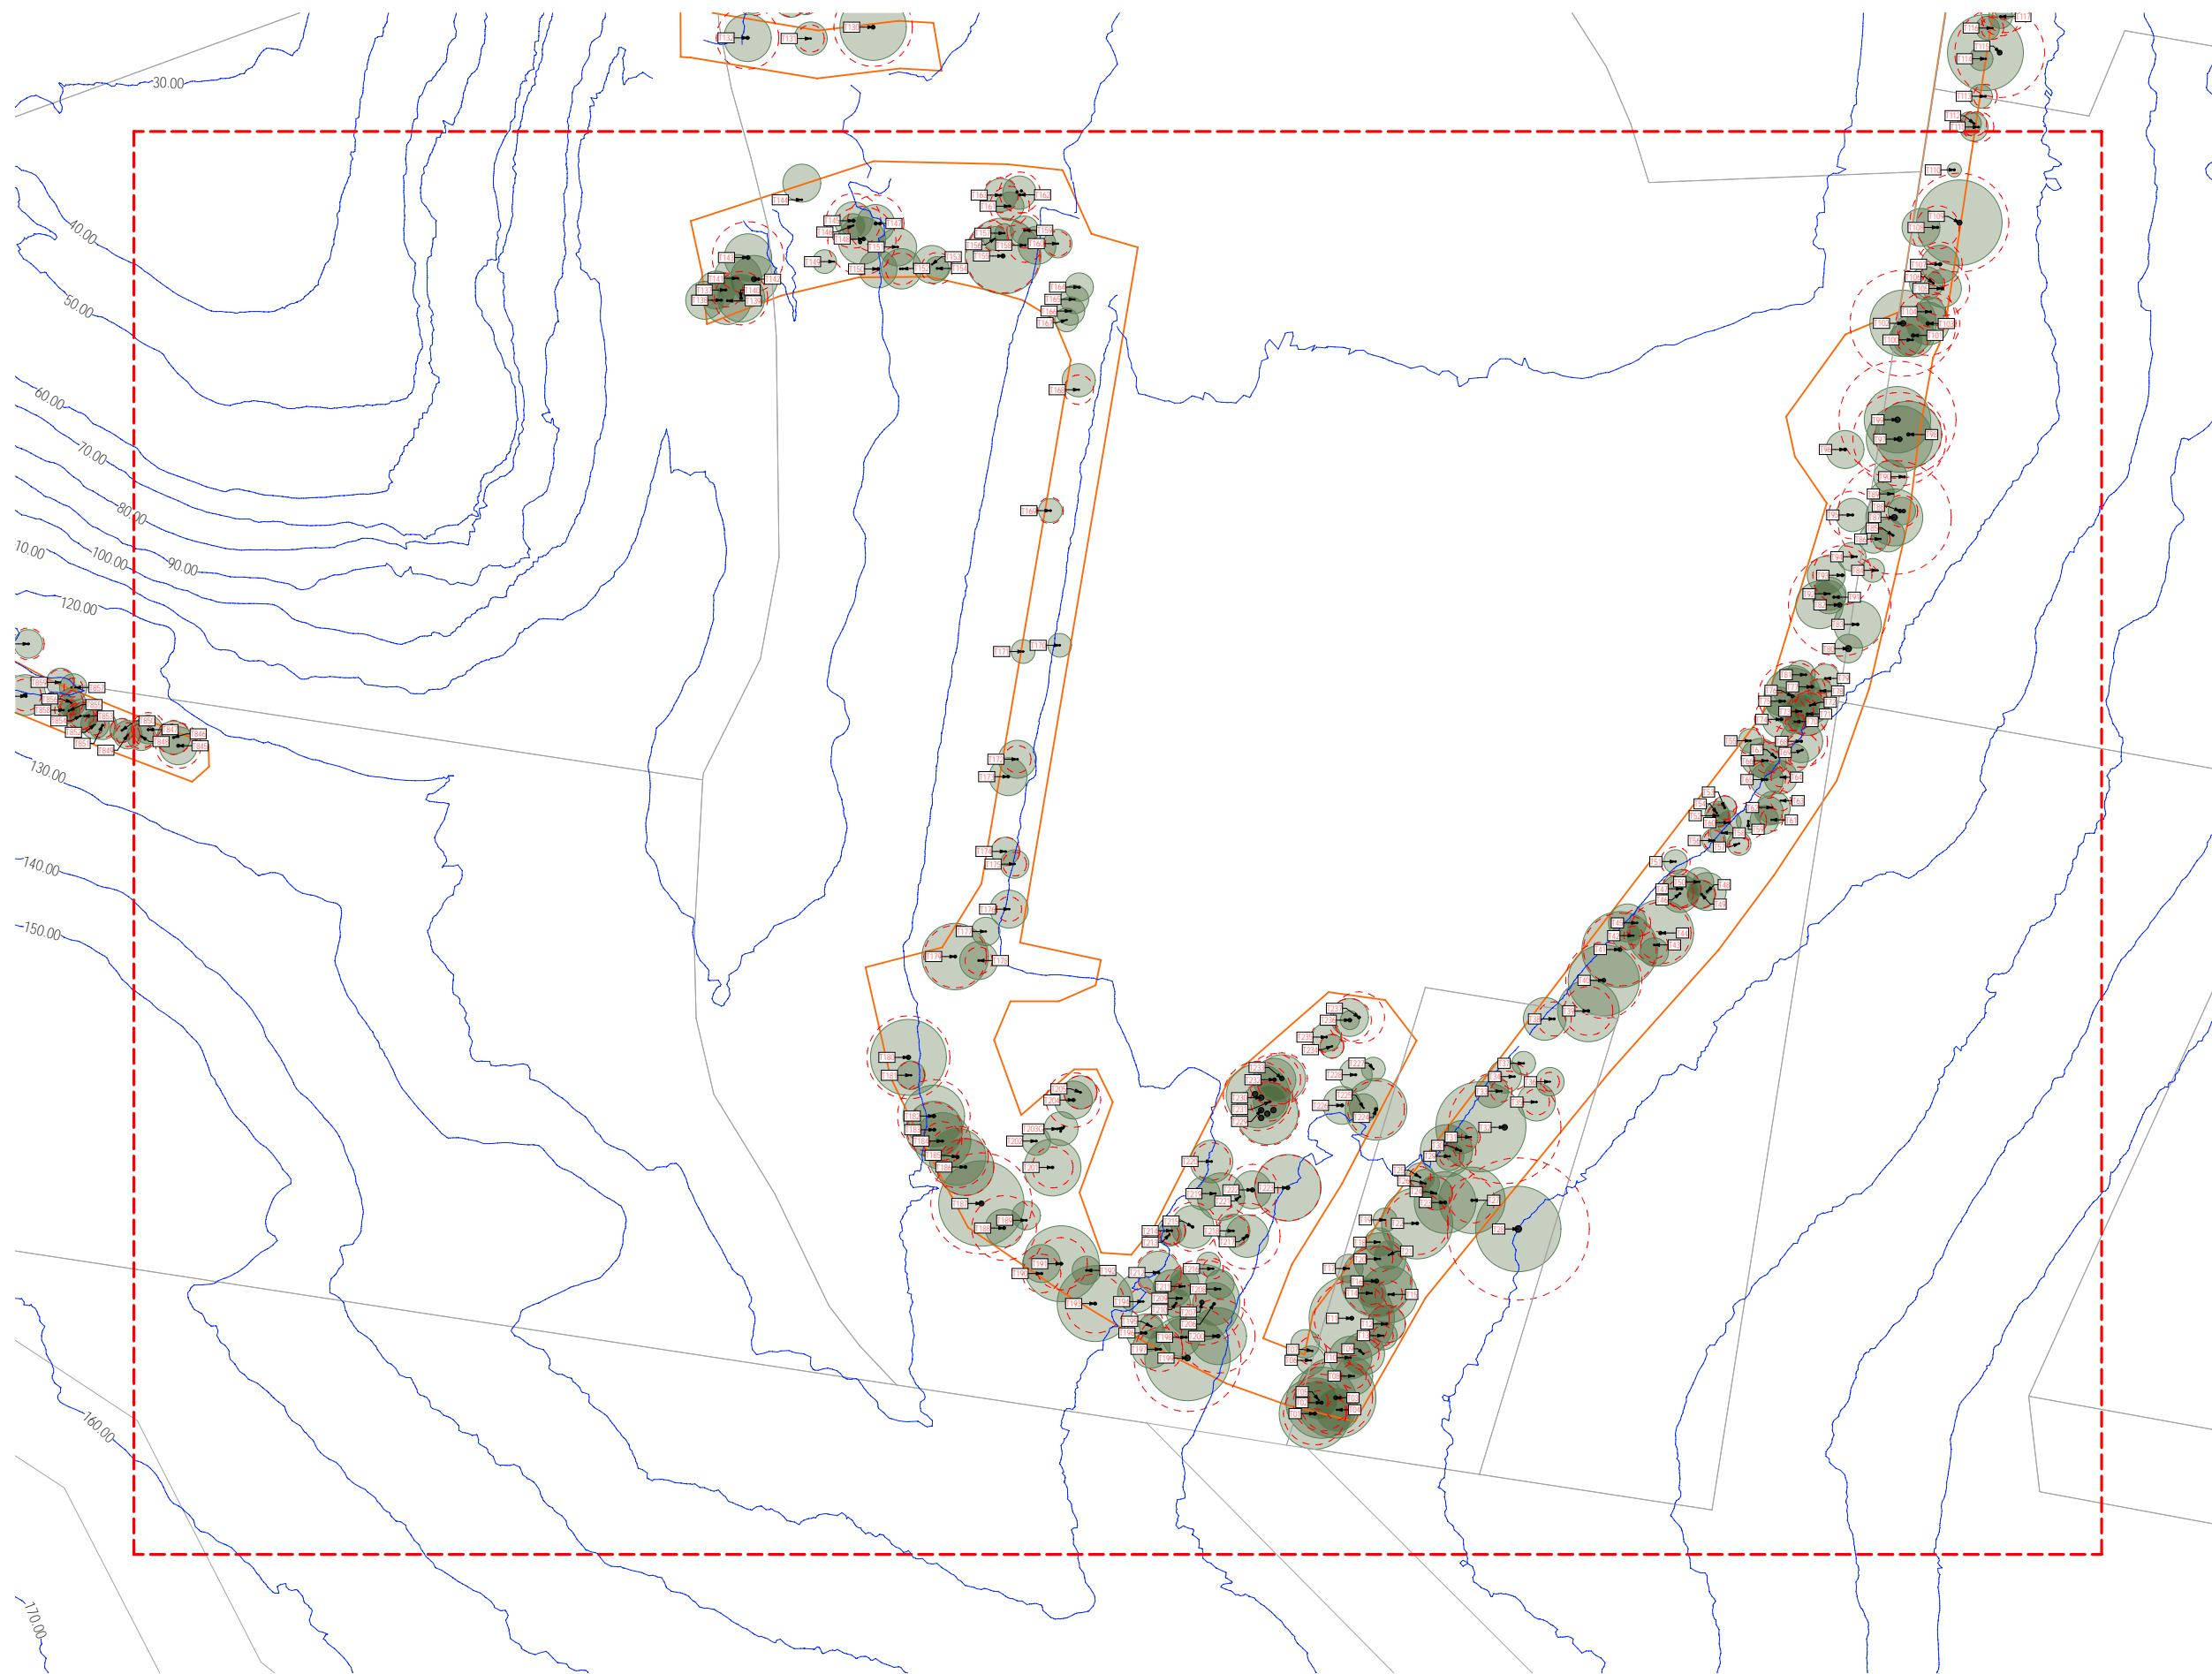
- Cadastre
- Tree Survey Extent
- 10m Contour
- Extent of canopy as verified by site measure
- Nominal Tree Protection Zone Radius (TPZ) (Only shown for Moderate and High condition rating trees)
- Tree Identification Number
