**Hornsby Shire Council
Revised Remedial Action Plan for Development of Westleigh Park
62 Quarter Sessions Road, Westleigh, NSW
SYDEN213135-2-R01**

Revised Remedial Action Plan for Development of Westleigh Park

62 Quarter Sessions Road, Westleigh, NSW

Prepared for
Hornsby Shire Council

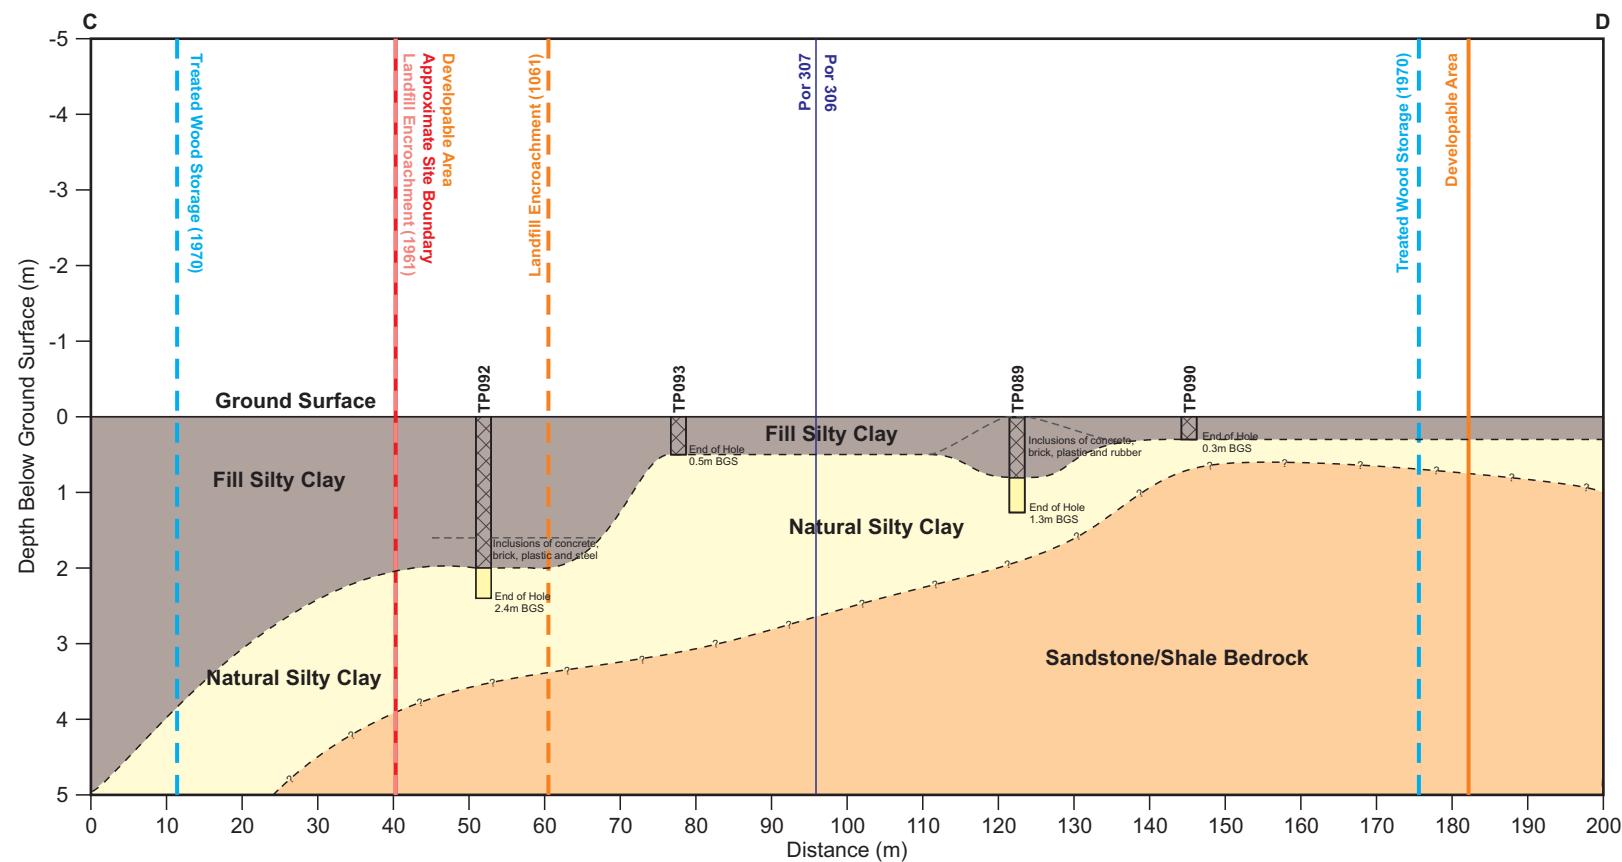
File Name: 43386_09

Note: As no site survey is currently available, the fill/natural contours are based on depth below ground surface

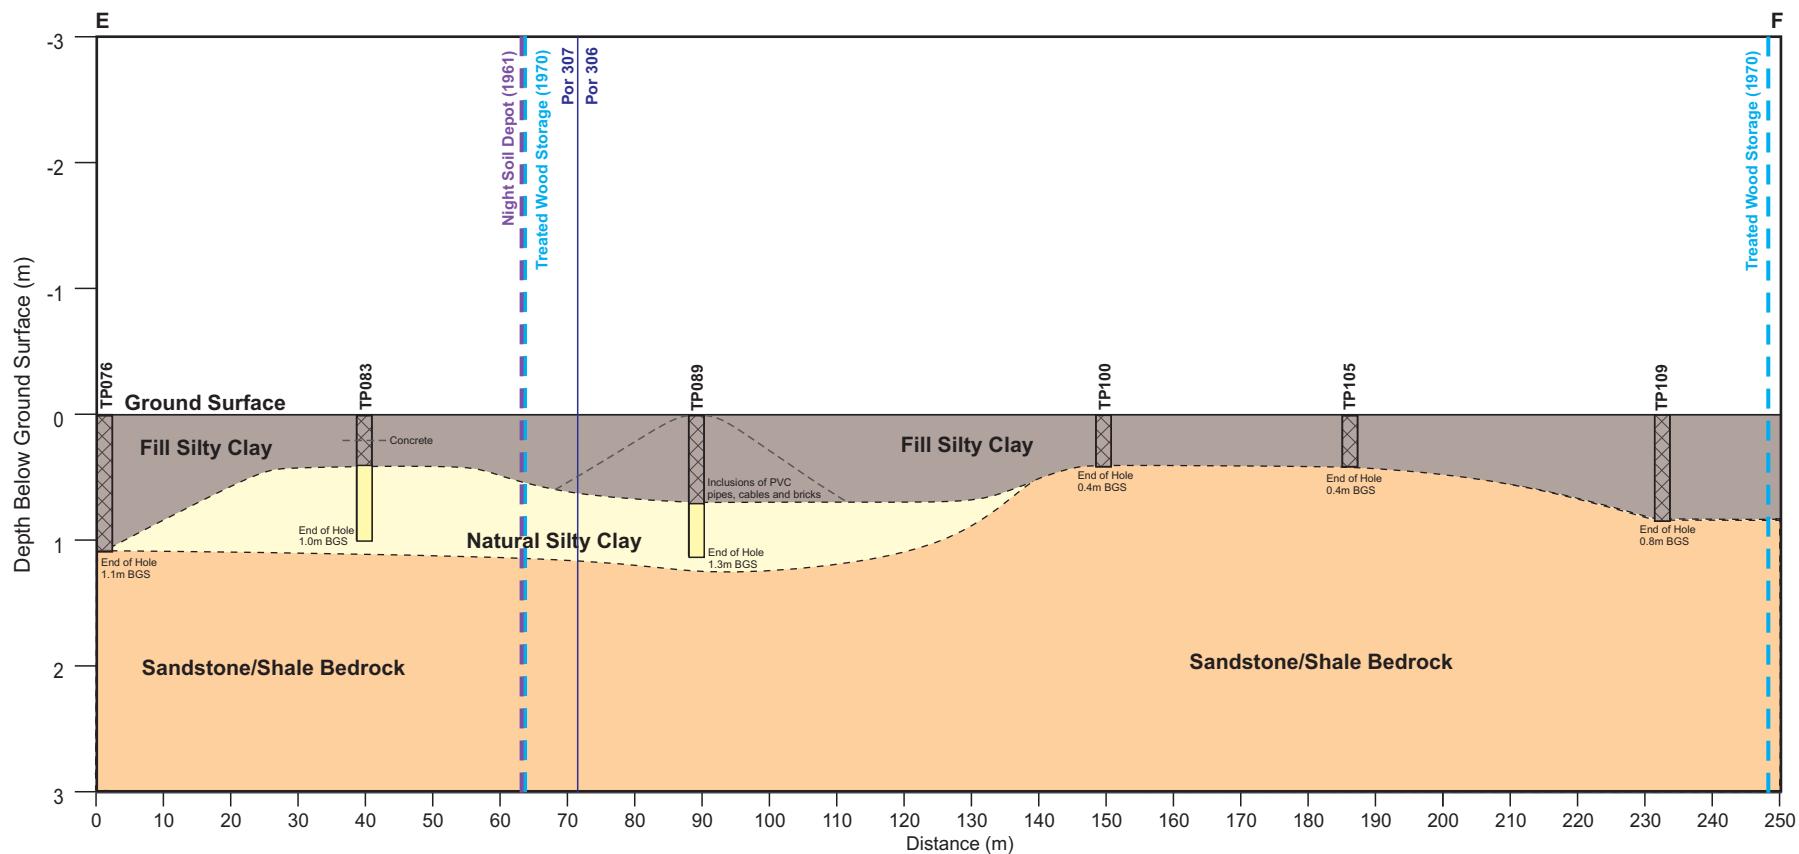
File Name: 43386_10

Note: As no site survey is currently available, the fill/natural contours are based on depth below ground surface

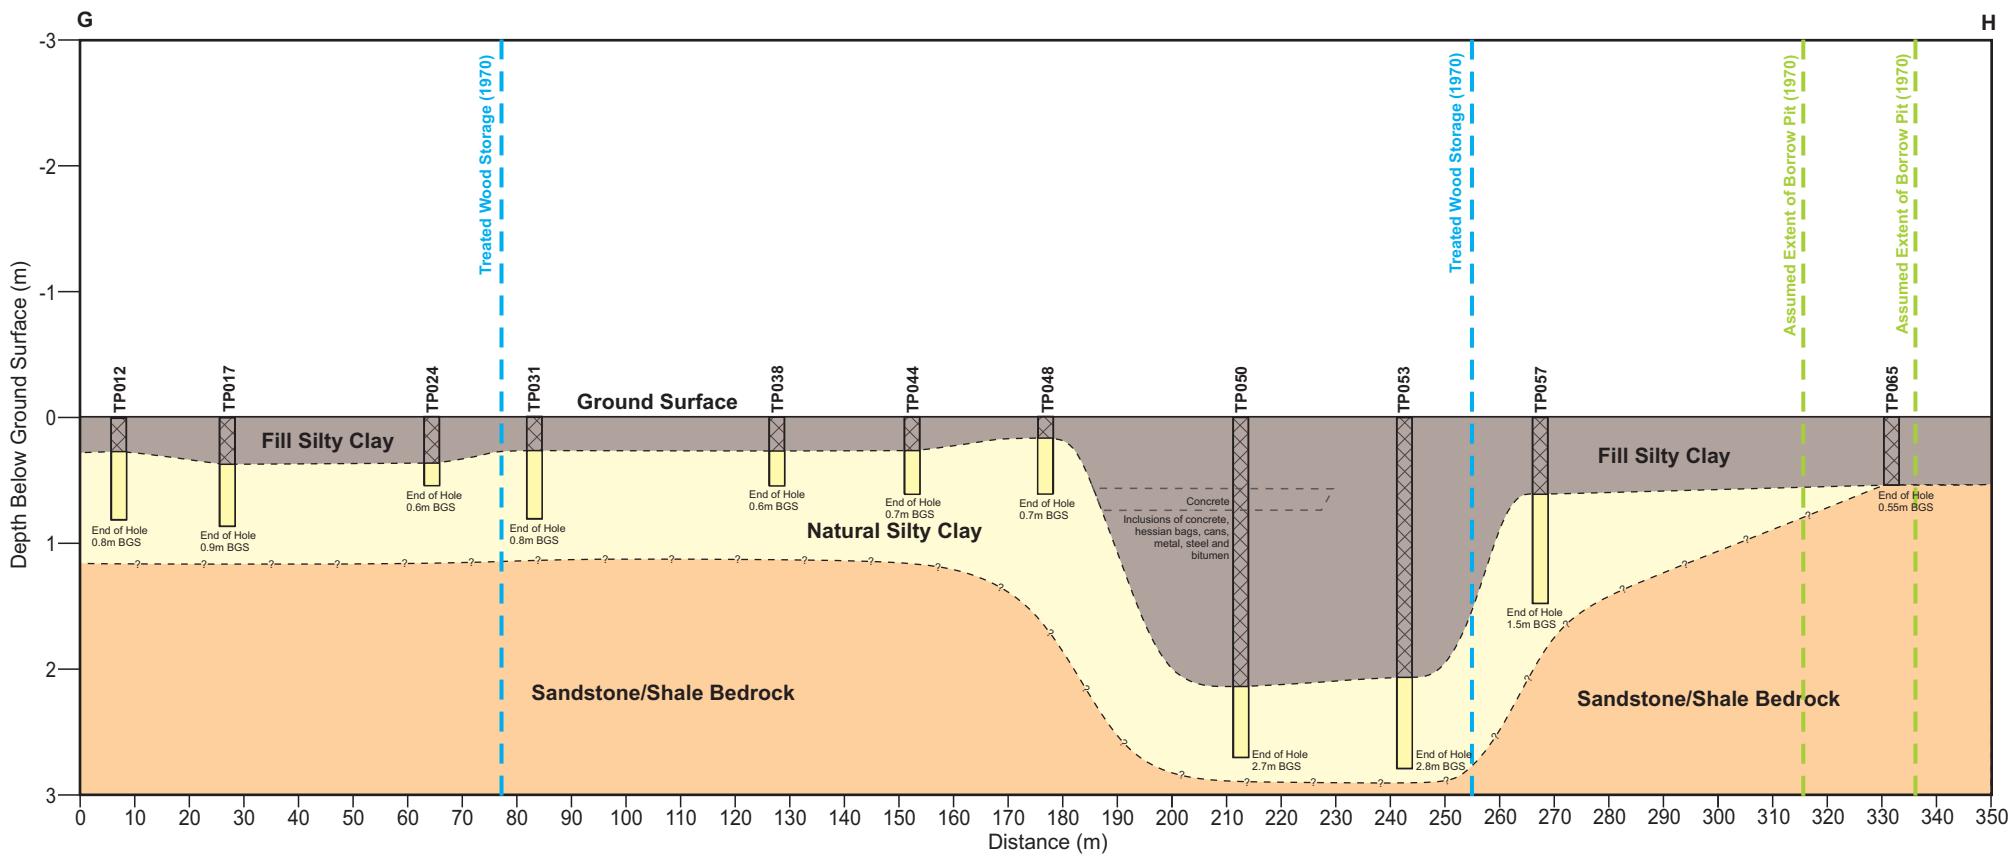
File Name: 43386_11

Note: As no site survey is currently available, the fill/natural contours are based on depth below ground surface

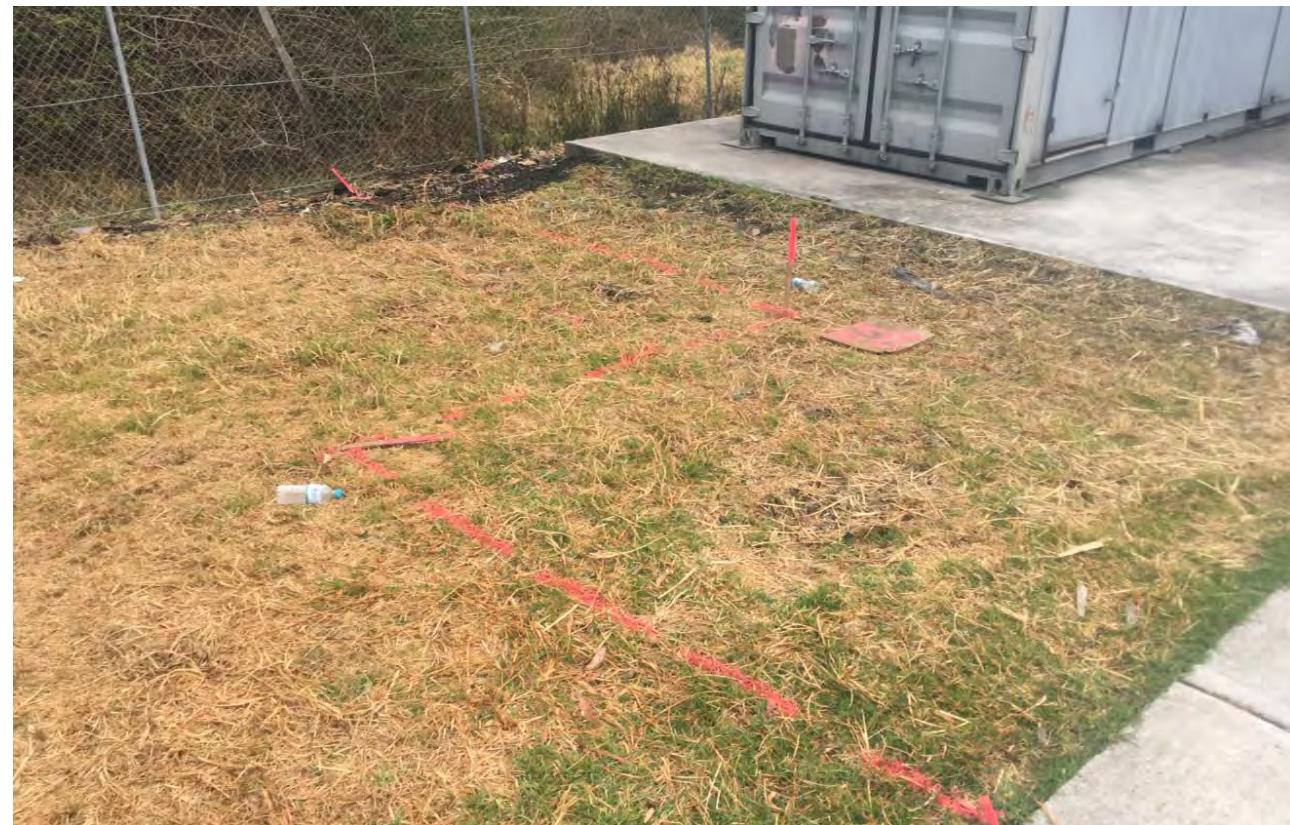
Plate 01

HA03 area prior to
excavation. Pink outline
shows the extent of
excavation required

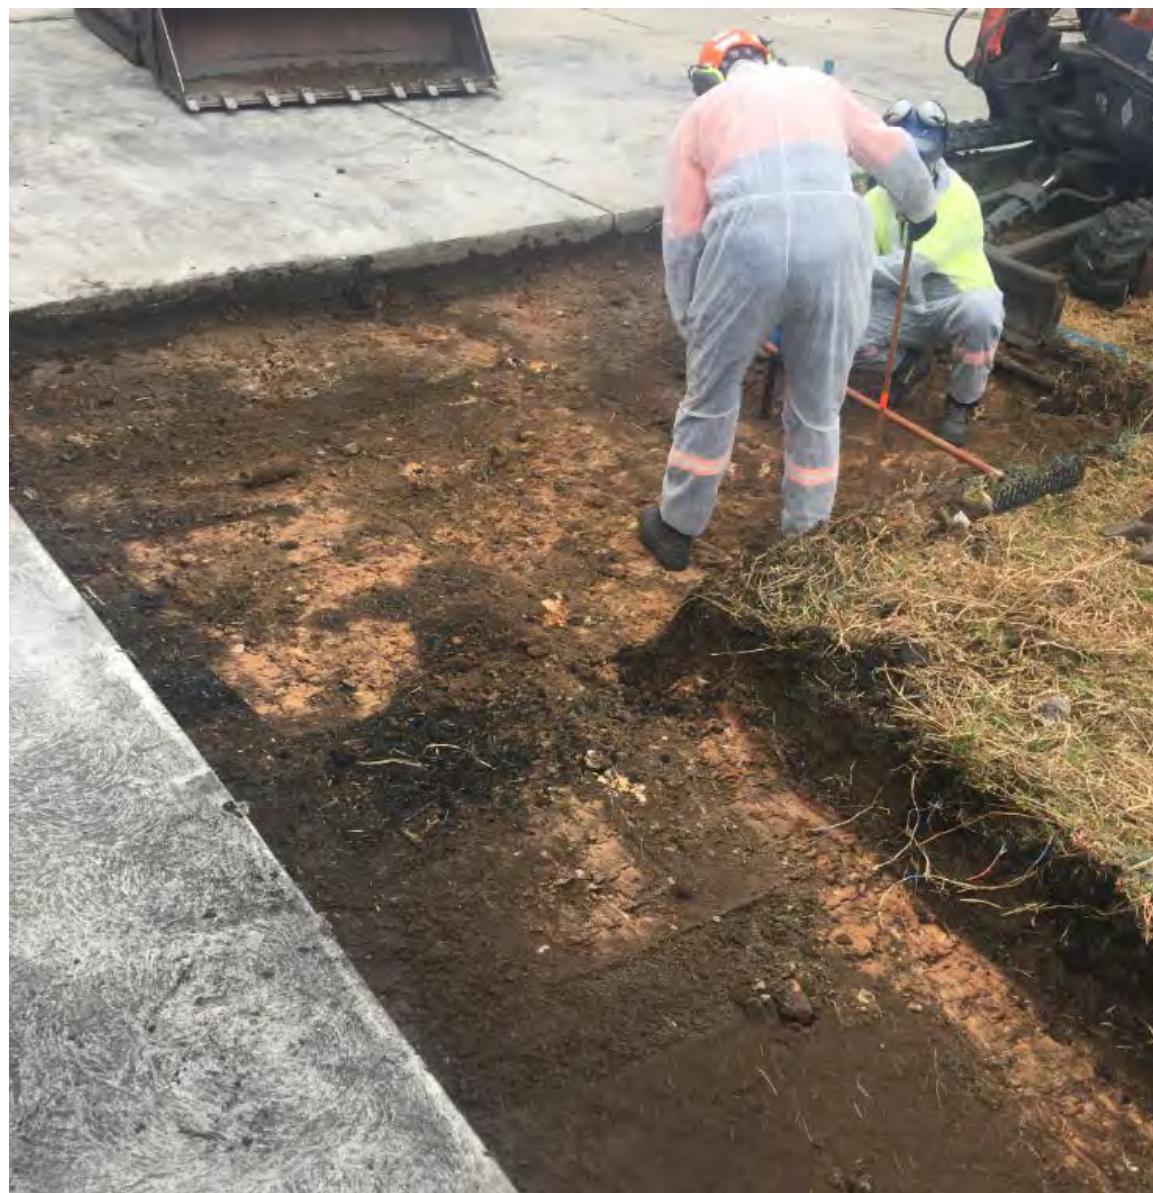
Plate 02

HA03 area following
excavation. Natural ground
surface can be seen at the
base of the excavation.

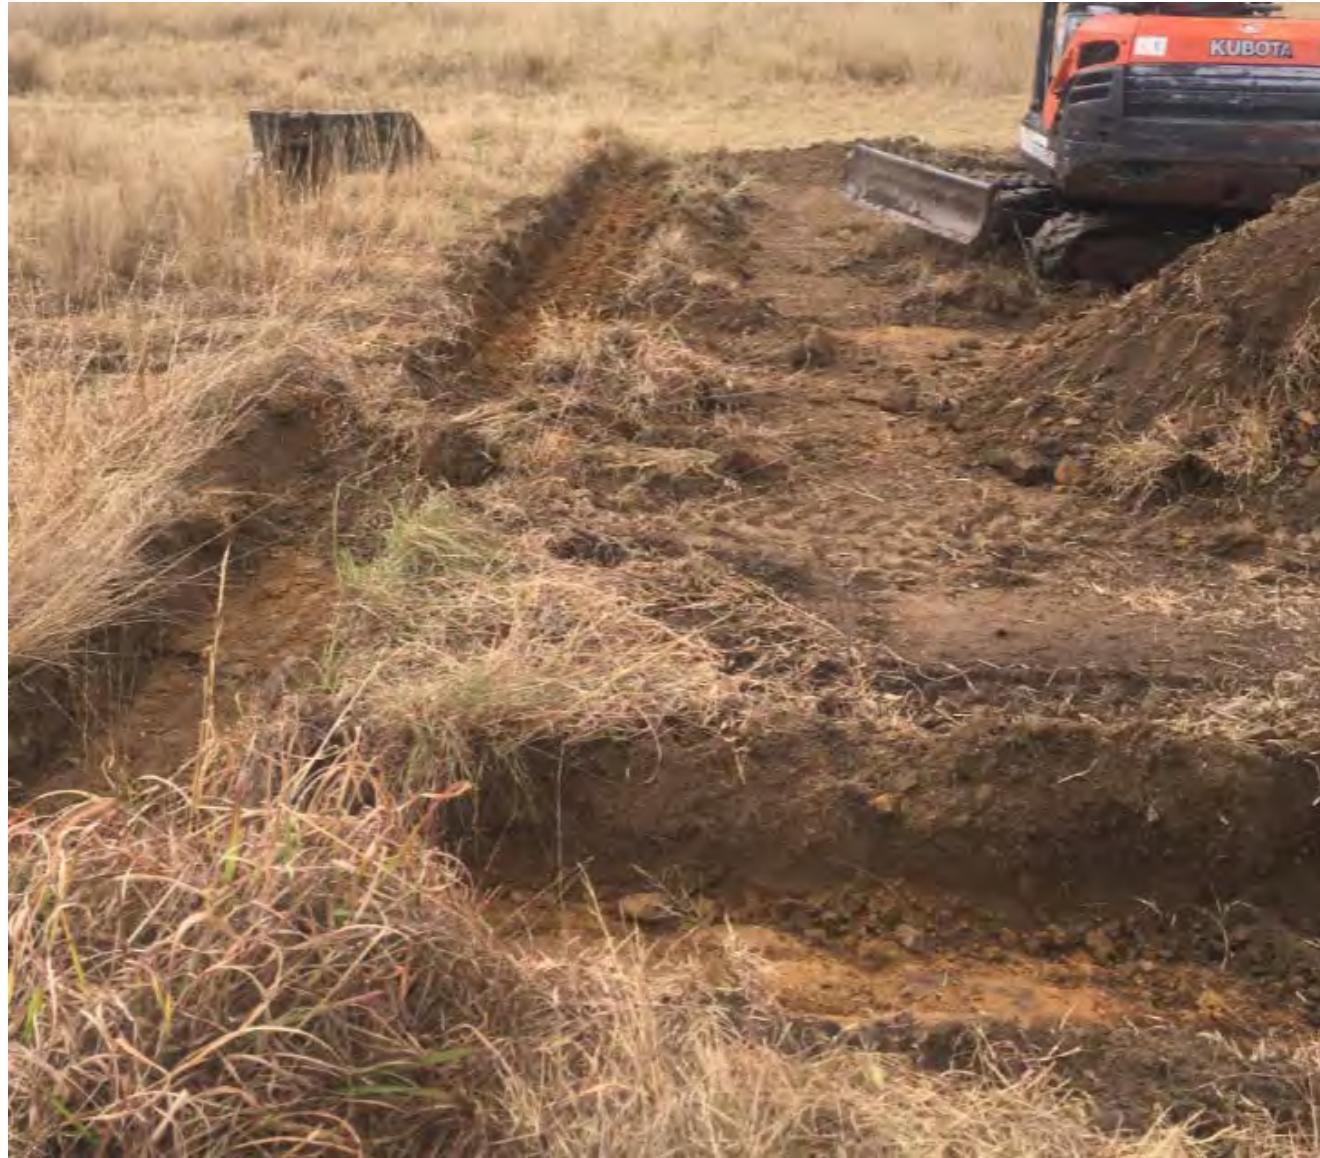
Plate 03

HA26 area during excavation.

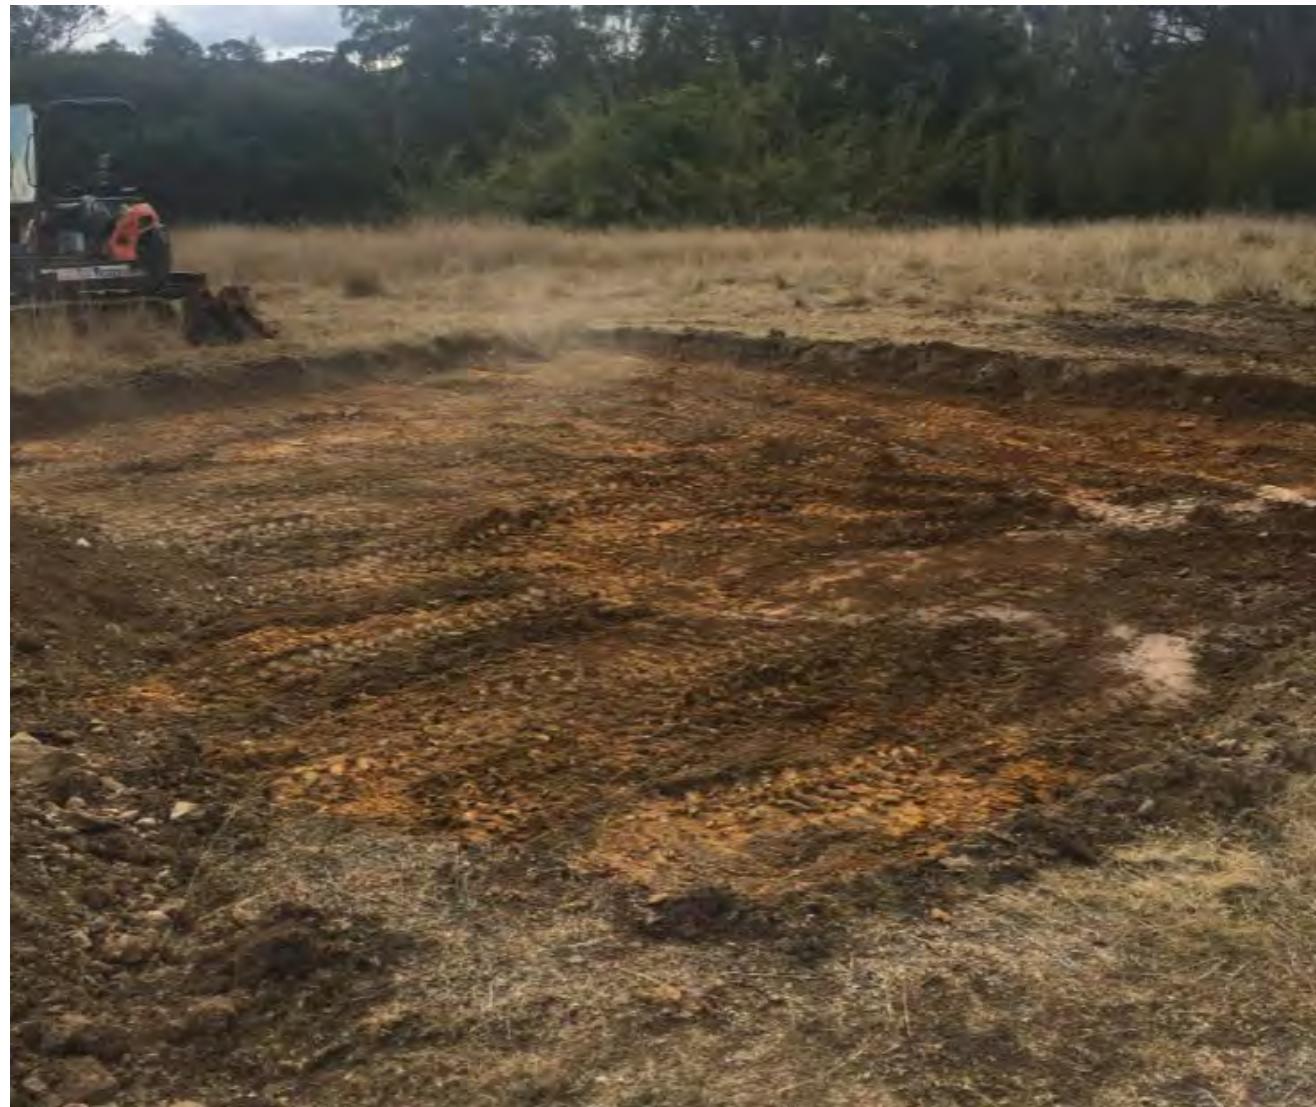
Plate 04

HA26 nearing completion of excavation.

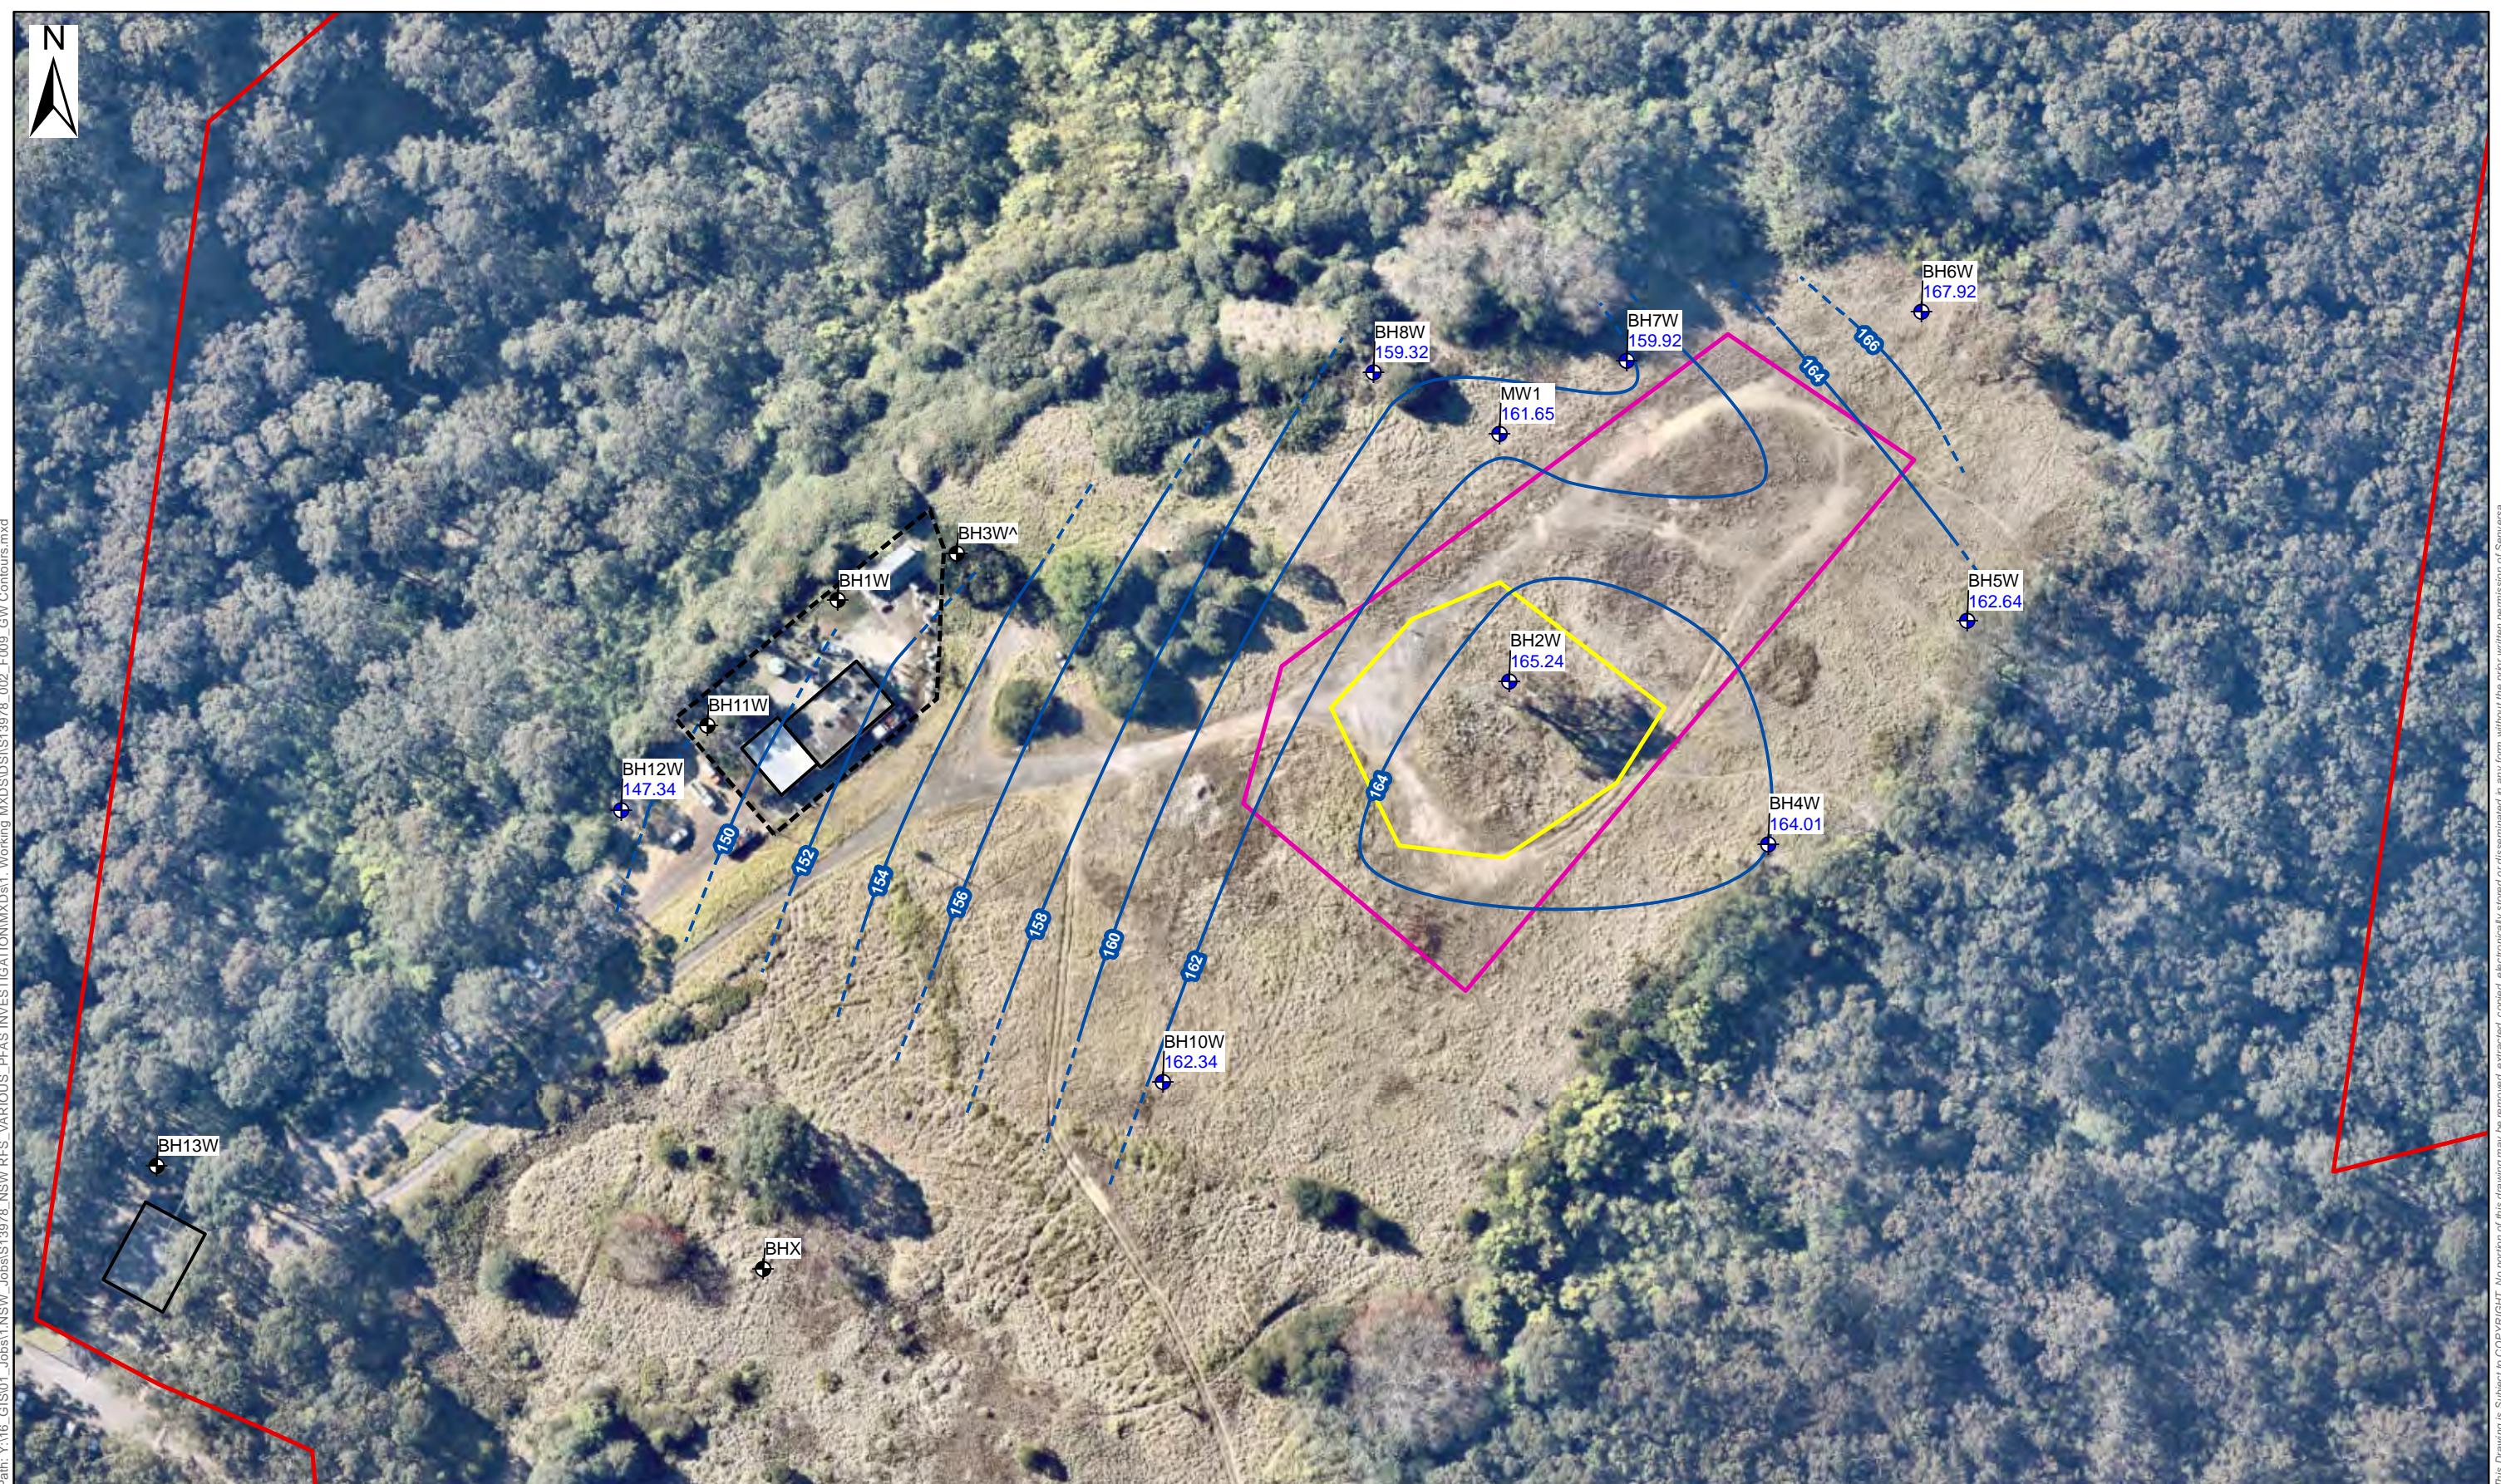
Legend	
Groundwater Monitoring Well - Gauged	Primary NSW EPA Investigation Area Boundary
Groundwater Monitoring Well	Potential AFFF Training Area
Dashed Line	Inferred Groundwater Contours
Solid Line	RFS Training Compound
Blue Arrow	Groundwater Flow Direction
Black Box	Indicative Site Boundary
White Box	Buildings

Groundwater gauging indicated groundwater beneath the site was comprised of moderately acidic freshwater at depths ranging from 6.355 m bgl to 29.517 m bgl located within the underlying fractured bedrock.

Senversa notes that as the site is located on the top of a ridge line, groundwater is likely to be a result of rainwater infiltration with subsequent flow directions following local topographical features and fractures within the underlying bedrock.
